## NES Soil Contamination Report

## Preliminary Site Investigation (PSI) Report

635 State Highway 23, Whatawhata

May 2019

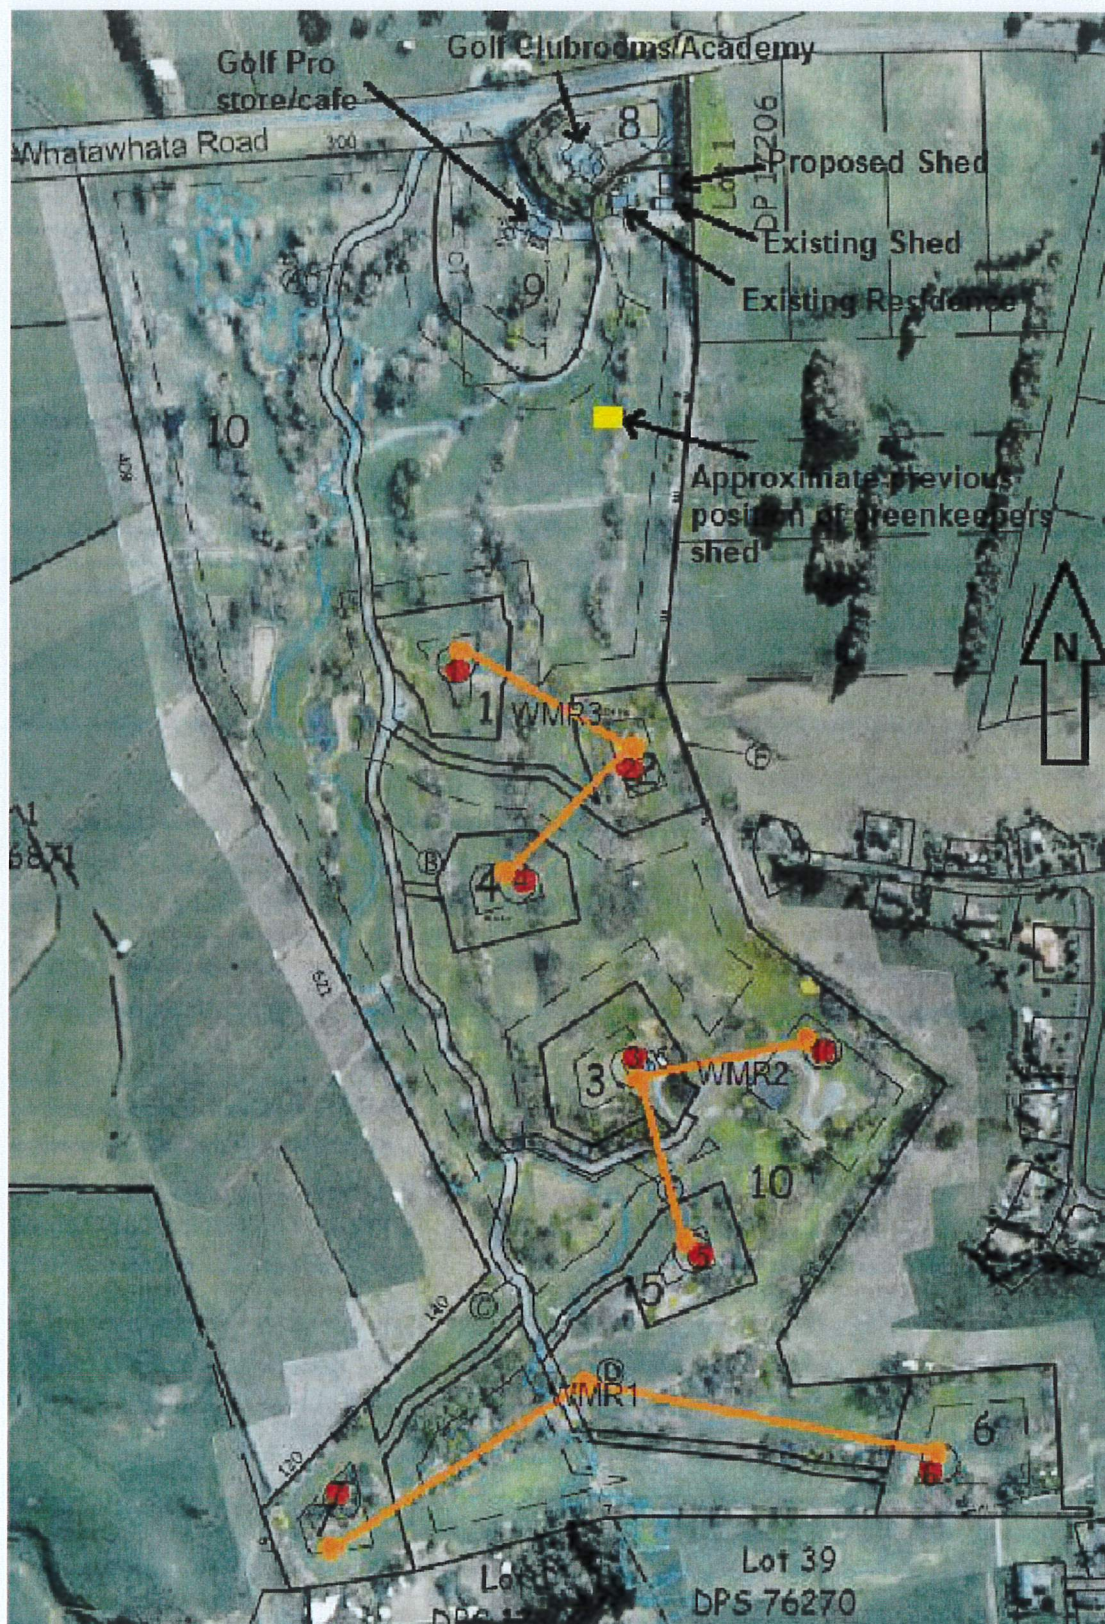
**Figure 1.** Proposed 635 State Highway 23 subdivision showing soil sampling positions of W1-7 & W10 (red dots) and WMR1-3 (orange dots) and previous position of greenkeepers' shed (yellow rectangle)

The soil sampling collected a discrete soil sample from each of the intended eight building sites on proposed Lots 1-7 & 10 (W1-7 & W10 – see red dots in Figure 1). W1-7 & W10 were tested for seven heavy metals, including arsenic, cadmium, lead and zinc (Table 1 and see attached Hill Lab Report 2157726).

Three 3-core composite samples were taken from the site, representing the intended eight building sites on proposed Lots 1-7 & 10 (WMR1-3 – see orange dots in Figure 1). WMR1 represented previous areas used as golf putting greens. In contrast, WMR2 & 3 represented fairway areas. Each of the three homogenised composite samples were analysed with the Hill Laboratories Multi-Residue Pesticide test, which focuses on an extensive range of soil-persistent pesticides that were known to be applied in New Zealand (see attached Hill Lab Report 2157726).

Eight rural-residential construction sites are proposed on Lots 1-7 & 10 of the subdivision, as indicated by the circles in Figure 1. Soil testing of the likely residential construction sites has indicated the average topsoil (0–10 cm) concentration of cadmium is slightly elevated (most likely due to occasional use of superphosphate) but the average level is unlikely to exceed the applicable residential NES SCS (Table 1). The soil analysis concentrations of arsenic, copper, chromium, lead, nickel and zinc were generally consistent and considered to be at, or not significantly above, natural background concentrations (Table 1). This is consistent with the apparent absence of significant historical buildings, orchards and structures at the sampling locations (Figures 1-3). Soil sample W1 revealed a slightly elevated arsenic concentration (26 mg/kg), that was relatively high (Table 1). Although this result is potentially isolated, it could indicate widespread elevated arsenic is present on the intended Lot 1 building site (Figure 1).

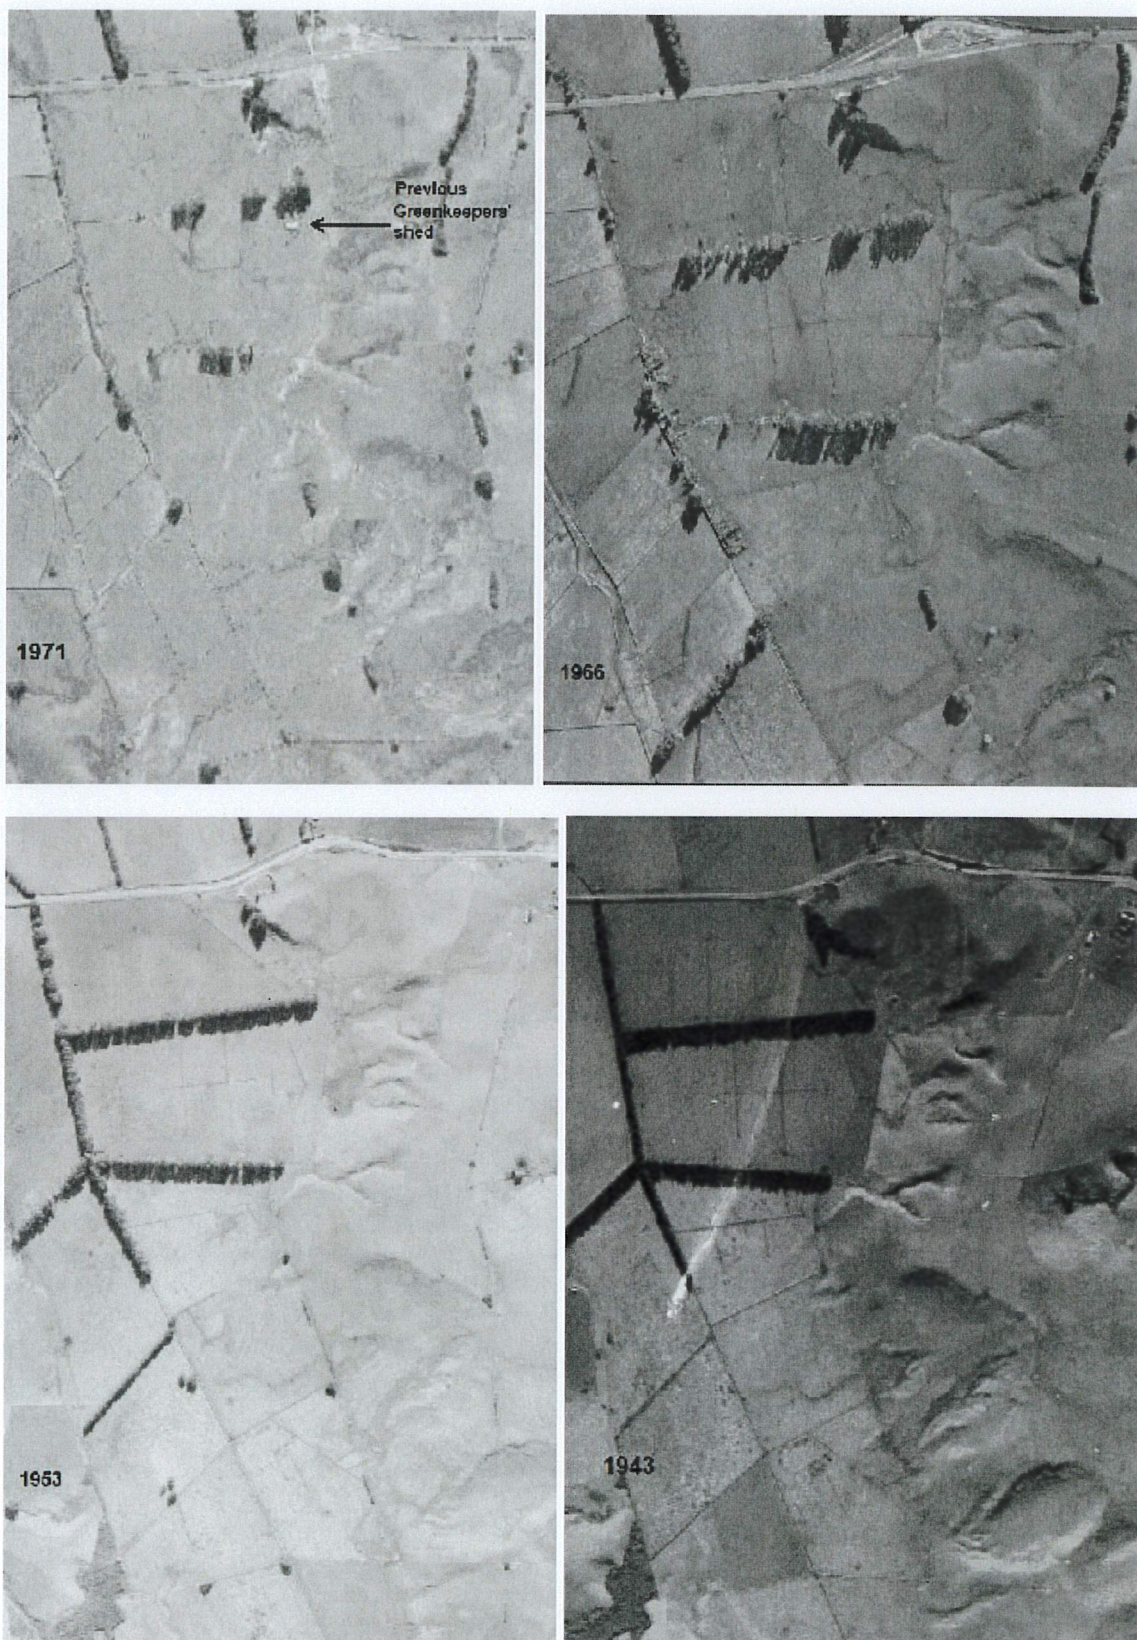
**Figure 3. 1971-1943 aerial photography of intended subdivision (refer to Figure 1)**

Aerial photos revealed no significant evidence for previous orchards, structures or buildings at or near the eight intended rural-residential building sites (Figures 1-3); based on the aerial photos the eight subject areas are conceptualised predominantly as long-term pastoral production land, that was converted to recreation golf course land in approximately 1970. The soil at or near the eight intended rural-residential building sites is considered at risk of cadmium contamination because any previously applied superphosphate included cadmium as an impurity.

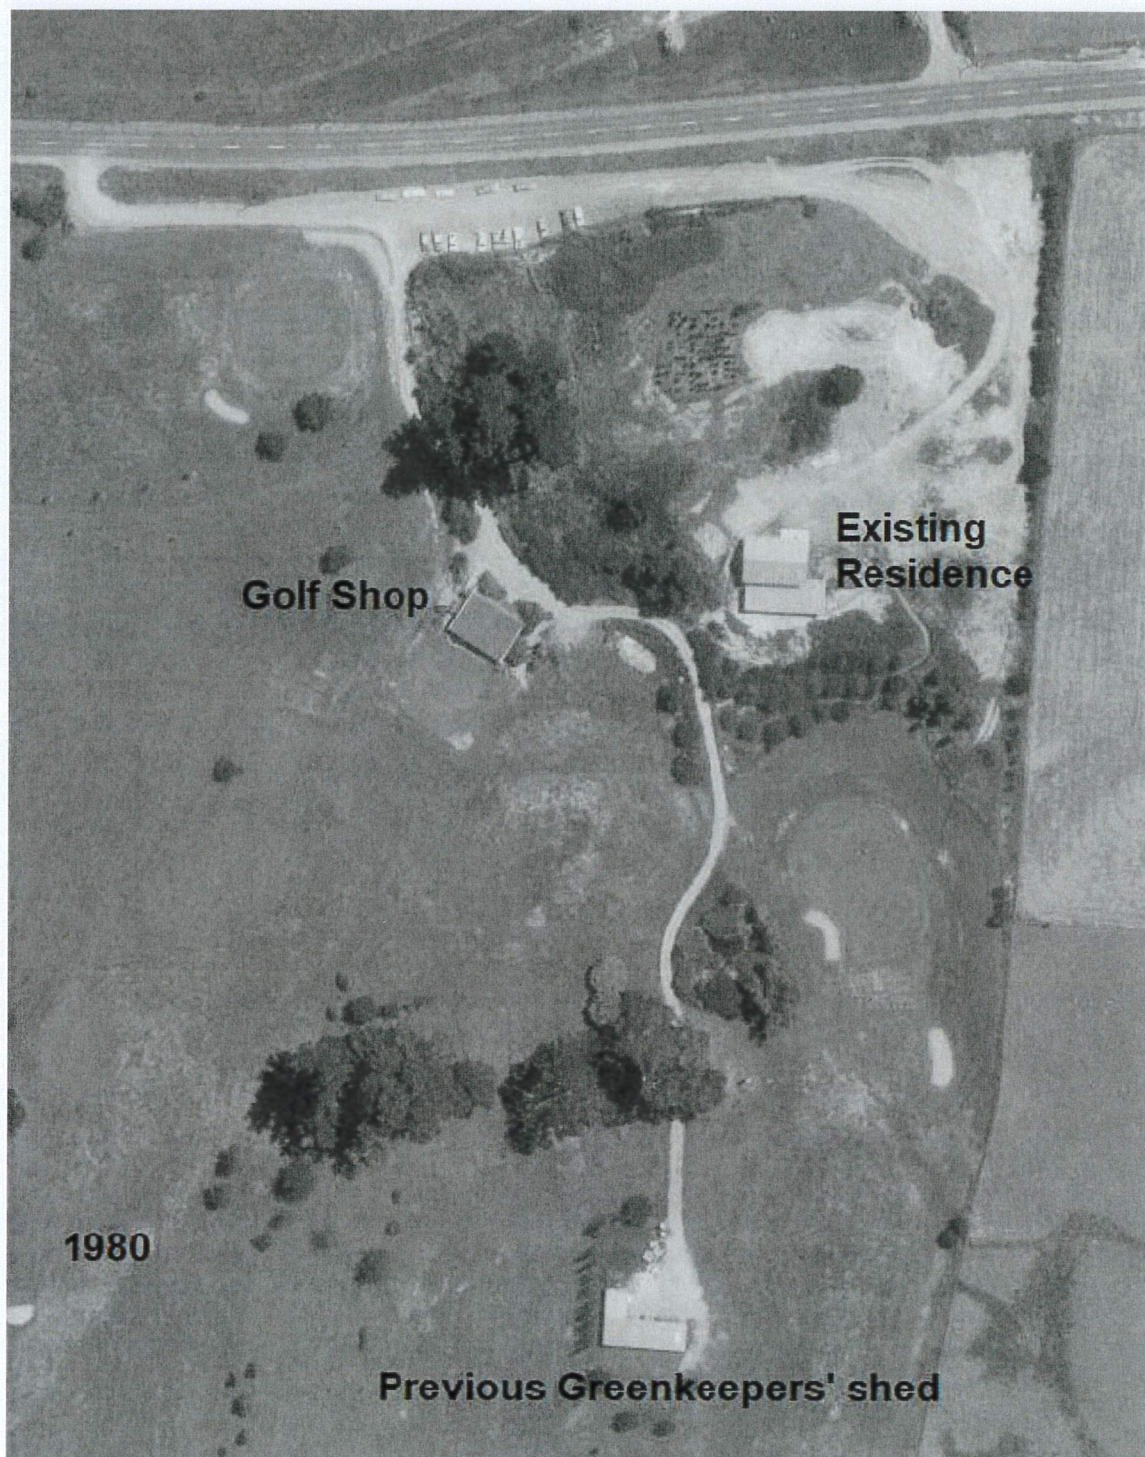
**Figure 4.** 1980 aerial photograph of northwest corner of subdivision site

The previous greenkeepers shed is depicted in the displayed 1980 aerial photography (Figure 4), along with the existing residence & original golf shop. The existing shed at the site within intended Lot 10 (Figure 1) was also likely used for greenkeepers' activity and appears in the 1995 aerial photography (Figure 2); the previous greenkeepers' shed (or parts thereof) may have been relocated (and modified) after 1991 to form the existing shed (Figure 2).

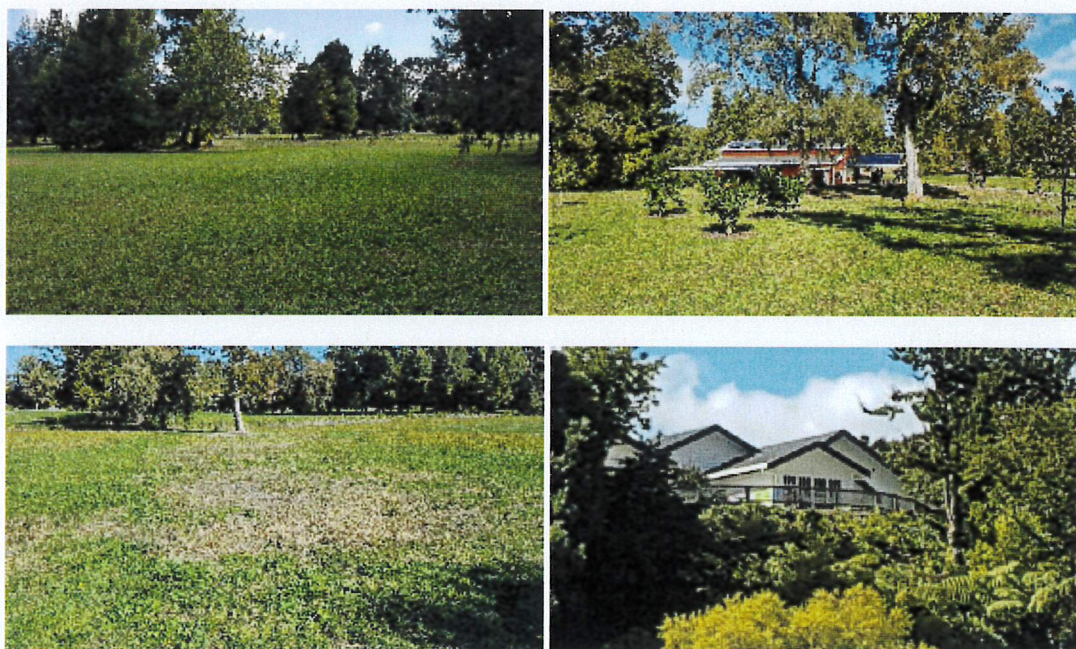
**Figure 5.** Photos of intended Lot 1 house site (top left), modern barn on Lot 3 (top right), previous position of greenkeepers' shed on Lot 10 (lower left) & golf clubrooms on Lot 8 (lower right)

It is recommended that further preliminary soil sampling for arsenic is performed over the intended building site on Lot 1, to ascertain the significance of the W1 sampling result for arsenic (26 mg/kg). Where the additional sampling indicates the W1 result was isolated, this PSI can be finalised with the results. Where the additional sampling indicates that widespread elevated arsenic is present, a Detailed Site Investigation is recommended.
