MCPHERSON QUARRY

EARTHFILL METHODOLOGY

PROJECT NO: HD1053
MCPHERSON RESOURCES LTD
REFERENCE: CI
20 SEPTEMBER 2019

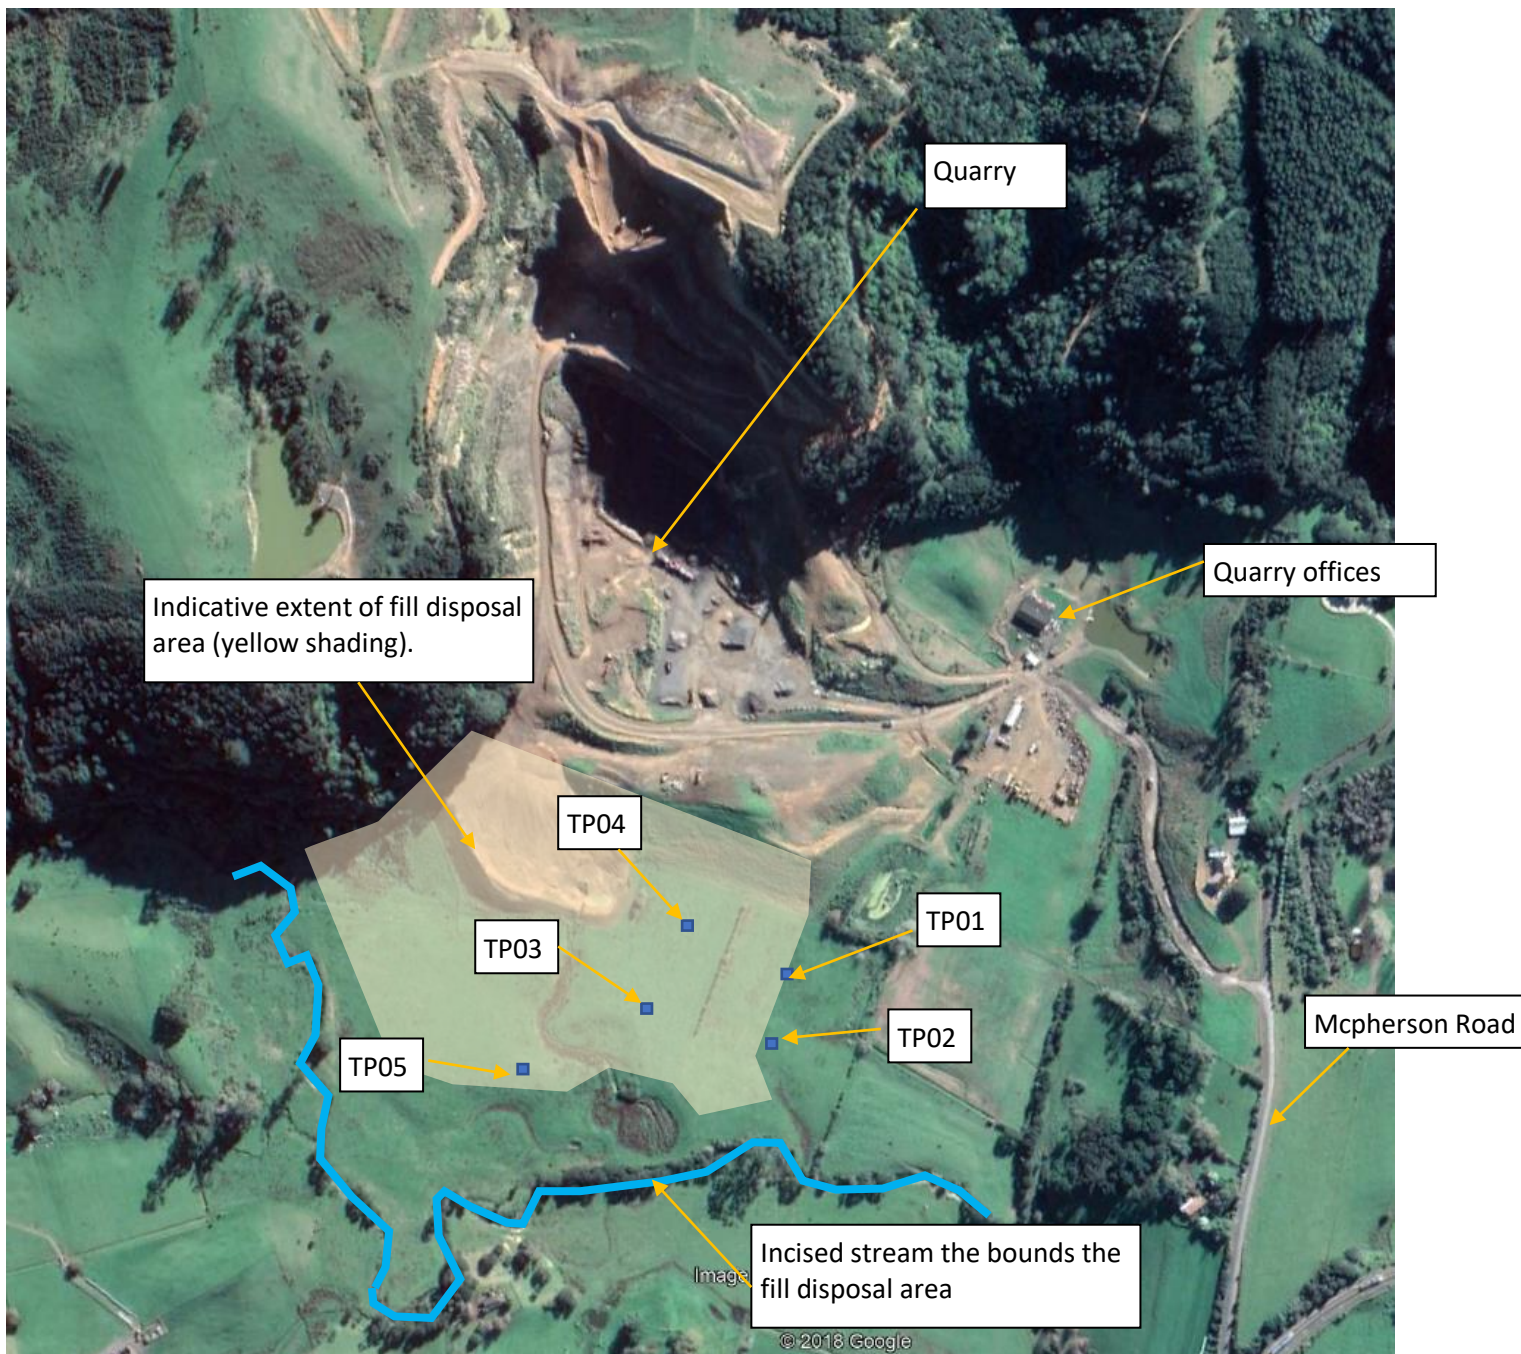
TITLE:
Site layout plan

Schematic plan of site layout

- Approximate location of Test pit

A schematic plan showing the proposed site layout is included in Appendix A.

Five test pits (TP01 to TP05) were excavated around the perimeter of the proposed final landform to investigate the nature of the ground in that area. A 40 ton Caterpillar 336F excavator and operator was supplied by the quarry to excavate the test pits. Test pits were photographed and logged by HD Geo. Test pits were backfilled at completion of the logging. Engineering logs and photos of the test pits are included in Appendix B.

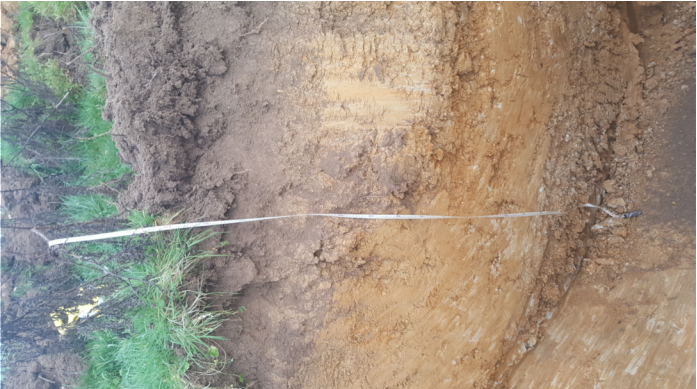
INVESTIGATION LOG										Job No.: HD1053								
		Client: McPherson Resources Ltd										No.: TP01								
		Project: McPherson Quarry										Date: 29.07.19								
		Location: -										Logged By: BY								
Co-ordinates: -										Checked By: SH										
Elevation: Ground																				
Geology	Geological Interpretation (refer to separate Geotechnical and Geological Information sheet for further information)	Depth (m)	Legend	Samples	PID (ppm)	Scala Penetrometer (Blows / 100 mm)					Vane Shear Strength (kPa) Vane: 2839		Water							
						2	4	6	8	10	12	14	16	18	-50	-100	-150	-200	-250	
Topsoil	Topsoil SILT (OL); light brown. Moist.		TS																	
Volcanic Ash	Silty CLAY (CL); light brown. Very stiff to hard; moist; moderate plasticity.	0.2	TS

End of test pit at 2.0 m. target depth. <div> <div> Shear Vanes <div> <div>Peak</div> <div>Remoulded</div> </div> </div> <div> Water <div> <div>Standing Water Level</div> <div>Out flow</div> <div>In flow</div> </div> </div> <div> Investigation Type <div> <div>Hand Auger</div> <div>Investigation Pit</div> <div>Machine Borehole</div> </div> </div> </div>

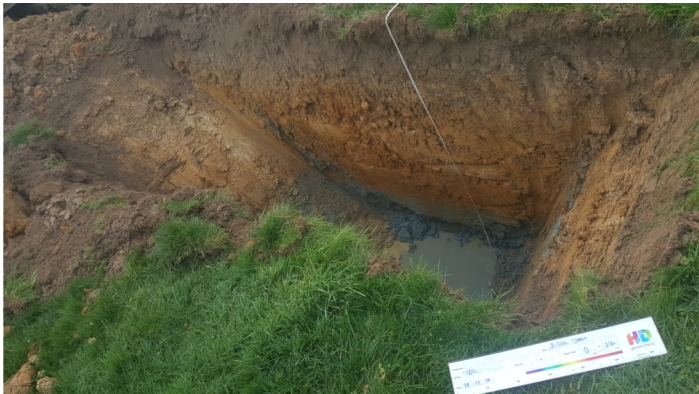
INVESTIGATION LOG										Job No.: HD1053									
	Client: McPherson Resources Ltd										No.: TP02									
	Project: McPherson Quarry																			
	Location: -										Date: 29.07.19									
Co-ordinates: -										Logged By: BY										
Elevation: Ground										Checked By: SH										
Geology	Geological Interpretation <small>(refer to separate Geotechnical and Geological Information sheet for further information)</small>	Depth (m)	Legend	Samples	PID (ppm)	Scala Penetrometer <small>(Blows / 100 mm)</small>					Vane Shear Strength <small>(kPa)</small> Vane: 2839					Water				
						2	4	6	8	10	12	14	16	18	-50	-100	-150	-200	-250	
Topsoil	Topsoil SILT (OL); light brown. Moist.	0.2

End of test pit at 3.2 m. Target depth. Water seepage at 0.4 m and 2.1 m.																		
		Shear Vanes					Water					Investigation Type

Groundwater seepage was noted in TP02 and TP03 only with remainder of test pits dry.

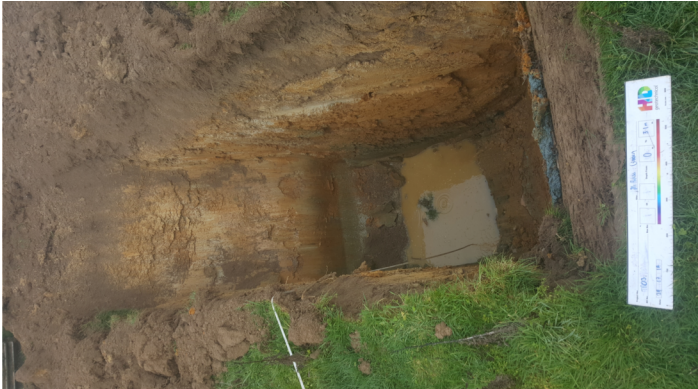
Geology	Geological Interpretation <small>(refer to separate Geotechnical and Geological Information sheet for further information)</small>	Depth (m)	Legend	Samples	PID (ppm)	Scala Penetrometer <small>(Blows / 100 mm)</small>	Vane Shear Strength <small>(kPa)</small> <small>Vane: 2839</small>	Water
Topsoil	Topsoil SILT (OL); light brown. Moist.	0.2	TS					
Residual Ash	Silty CLAY (CL); light orange, motthed white. Very stiff to hard; moist; moderate plasticity.	0.4	TS					
		0.6	TS					
		0.8	TS				137	
		1.0	TS				116	
Aluvium	Silty CLAY (CL); orange. Very stiff; saturated; moderate plasticity.	1.2	TS					
		1.4	TS					
		1.6	TS					
		1.8	TS					
		2.0	TS					
		2.2	TS					
	2.2m: light grey. low to moderate plasticity.	2.4	TS					
		2.6	TS					
		2.8	TS					
		3.0	TS					
	EOH: 3.10m

End of test pit at 3.1 m. Target depth.
Water seepage at 1.5 m.

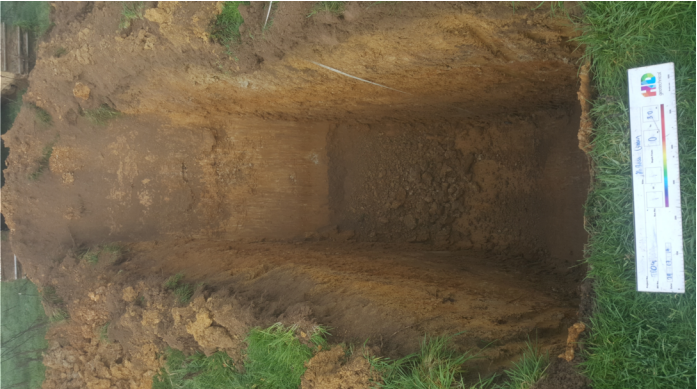
INVESTIGATION LOG						Job No.: HD1053	
		Client: McPherson Resources Ltd Project: McPherson Quarry Location: - Co-ordinates: - Elevation: Ground						No.: TP04 Date: 29.07.19 Logged By: BY Checked By: SH	
Geology	Geological Interpretation (refer to separate Geotechnical and Geological Information sheet for further information)	Depth (m)	Legend	Samples	PID (ppm)	Scala Penetrometer (Blows / 100 mm)	Vane Shear Strength (kPa) Vane: 2839		Water
						2 4 6 8 10 12 14 16 18	50 100 150 200 250		
Topsoil	Topsoil SILT (OL); light brown. Moist.	0.0 - 0.2	TS						
Volcanic Ash	Silty CLAY (CL); white. Stiff to very stiff; moist; moderate plasticity.	0.2 - 0.8	TS						
Waipapa Group	CLAY (CL); light brown. Very stiff to hard; moist; low to moderate plasticity.	0.8 - 3.0	TS						
	EOH: 3.00m	3.0							
Photo		Remarks

End of test pit at 3.0 m. Target depth. <div> <div> Shear Vanes

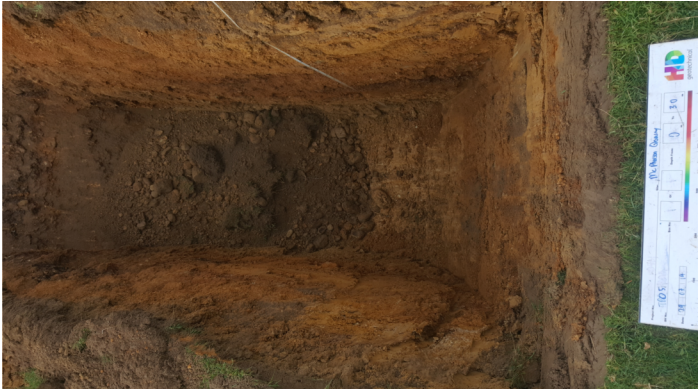
36		
	Silty COBBLES (GM); light brown. Cobbles, subround, poorly graded; tightly packed. 1.5m: moderate plasticity. Manganese staining.	1.5 - 3.0

End of test pit at 3.0 m. Target depth. <div> <div> Shear Vanes

In general, the test pits indicated most of the proposed fill disposal area is underlain by very stiff silty clay interpreted as volcanic ash deposits to below 3 m depth. Sandy cobbles with some silt interpreted as river deposits were encountered from approximately 2 m depth in TP02 and TP05 on the southern extent of the site. The encountered ground conditions are consistent with the expected geology of the area.
