# Ecological Impact Assessment

McPherson Quarry  
Prepared for McPherson Resources Ltd  
15 October 2019

Report Number 1708203-001 V5

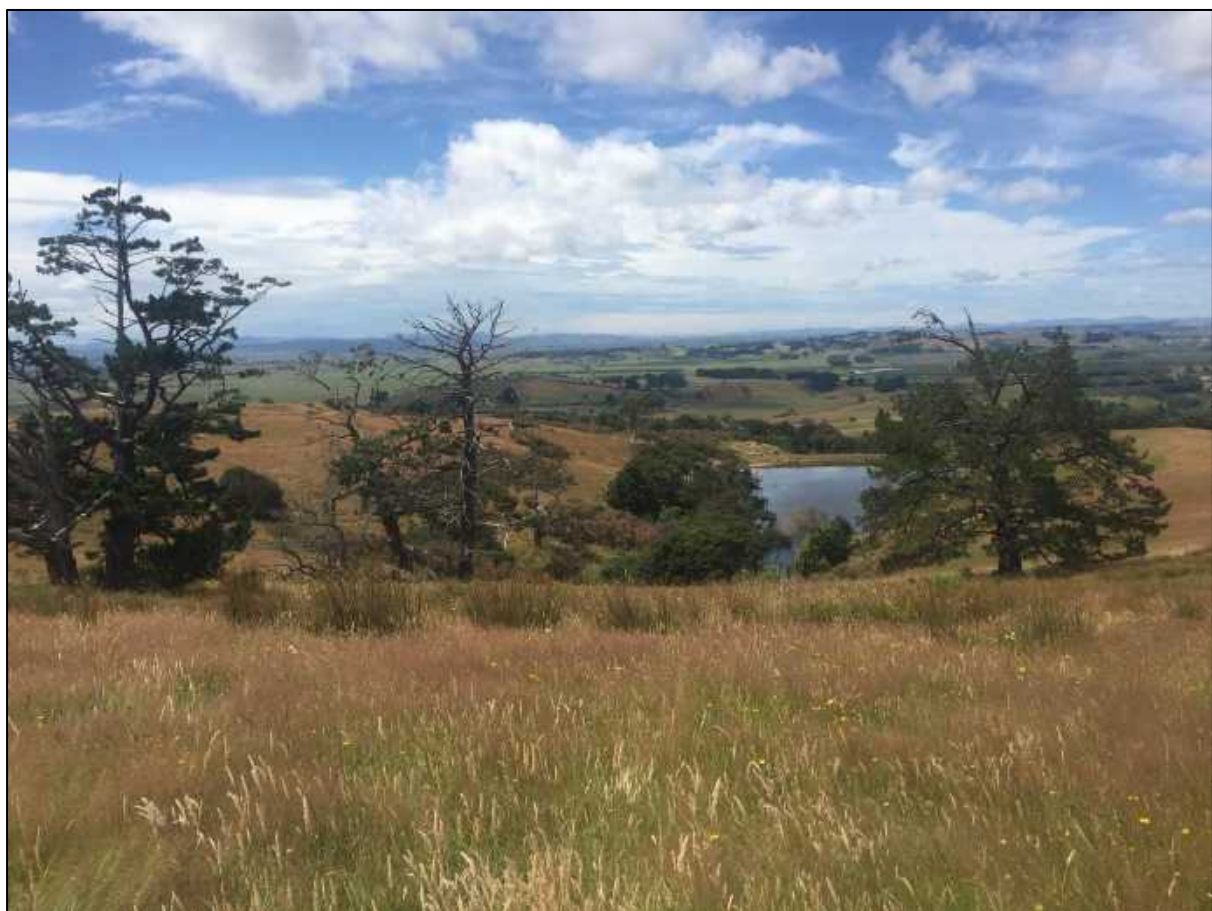
Plate 1 Scattered specimen trees representing bat roosting habitat.

Potential bat roosting habitat was noted in the form of scattered large senescing pine trees (*Pinus* spp.), kahikatea (*Dacrycarpus dacrydiodes*), rimu (*Dacrydium cupressinum*) and totara (*Podocarpus totara*), all with diameters at breast height measured at greater than 80cm and

containing potential roosting features (Plate 1). Foraging sites were observed along linear bush edges and across small ponds within the site. Potential bat flightpaths were also noted along the site perimeter, haul roads and streams.

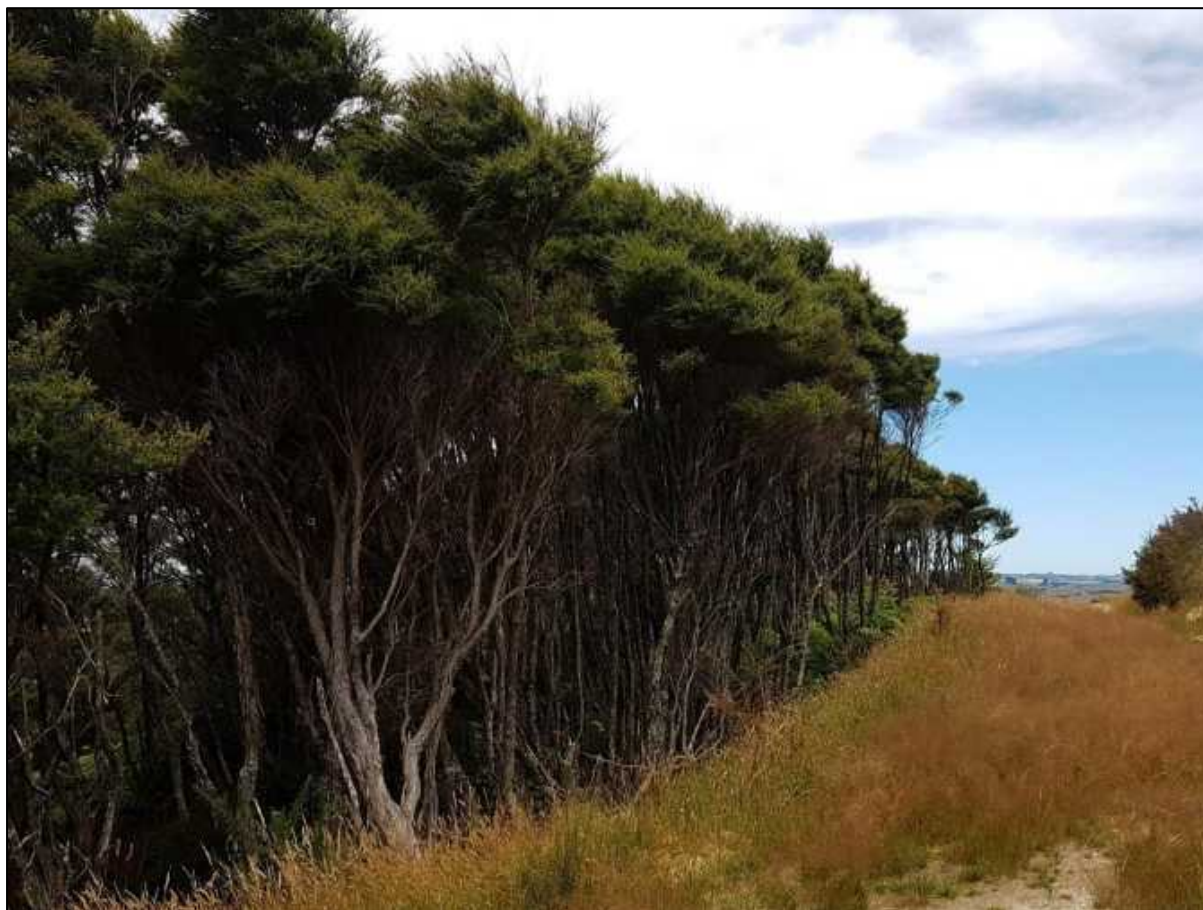
Plate 2 Kānuka-dominant bush block on eastern boundary of site.

Arboreal lizard habitat on-site appeared to be suitable within the kānuka-dominant bush block (Plate 2); however, the majority of the site presented low-quality habitat through pasture grasses. Ground-dwelling skink habitat was assessed as moderate quality due to the sparse leaf litter layer within the bush fragments, and lack of logs and other preferred habitat features within the ground layer. Grazed pasture grasses across the site provided a homogenous novel habitat for ground-dwelling skinks; however, a lack of logs or debris features was noted.

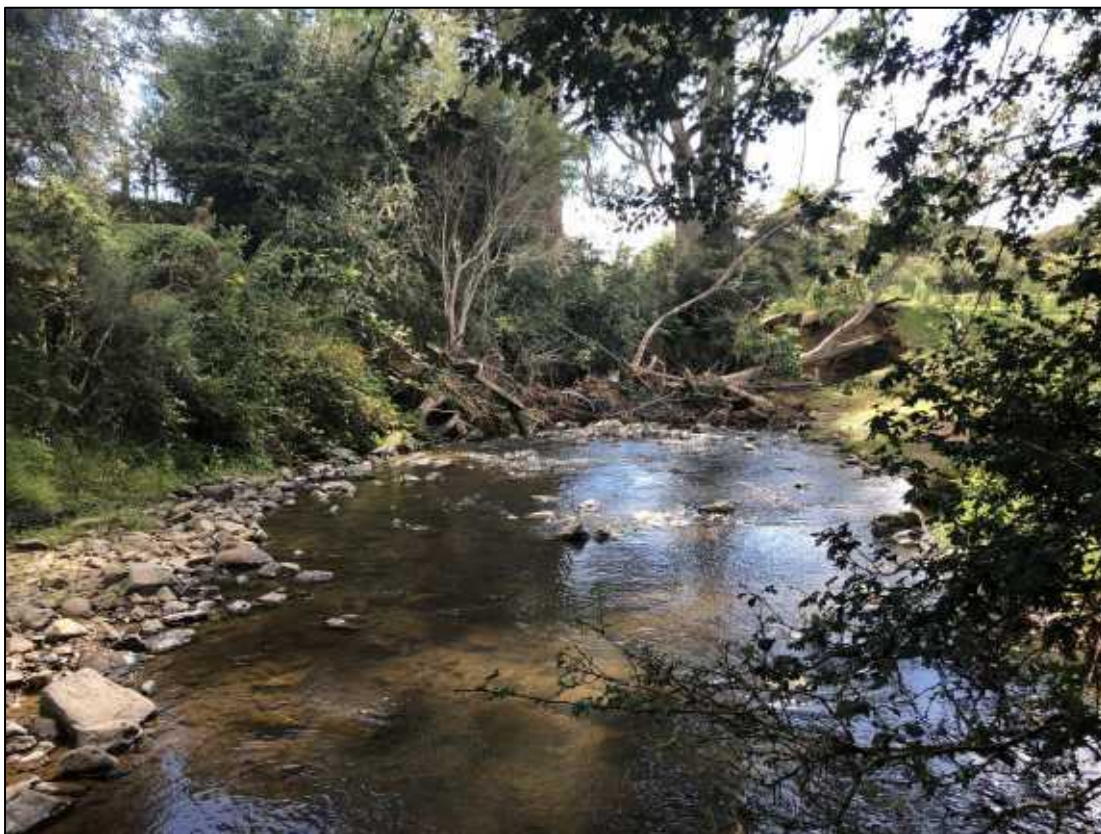
*Plate 4 Stream 1 classified as a permanent, hard-bottomed stream*

Stream 1 had well-defined banks, steeply incised in places and ranging from c. 0.3m to several metres in height with channel widths varying between c. 3m and 6m. Evidence of scouring from flood flows was noted in places with bank undercuts and slumpage present. While this process of bank erosion was considered natural, the rate of erosion was likely occurring faster than expected due to the absence of complex riparian vegetation. Stock had direct access to the water in most places (Plate 5) including two fords for vehicle crossings where sheep were seen crossing the stream. Riparian vegetation in the assessed section was patchy and consisted predominantly of grazed and rank grass and exotic species such as hawthorn (*Crataegus monogyna*), gum trees (*Eucalyptus* sp.), Darwin's barberry (*Berberis darwinii*), gorse (*Ulex europaeus*), and kānuka (*Kunzea robusta*). At the eastern end of the site, a fallen gum tree was accumulating debris and organic foam, as well as facilitating notable scouring of the true right bank (TRB).

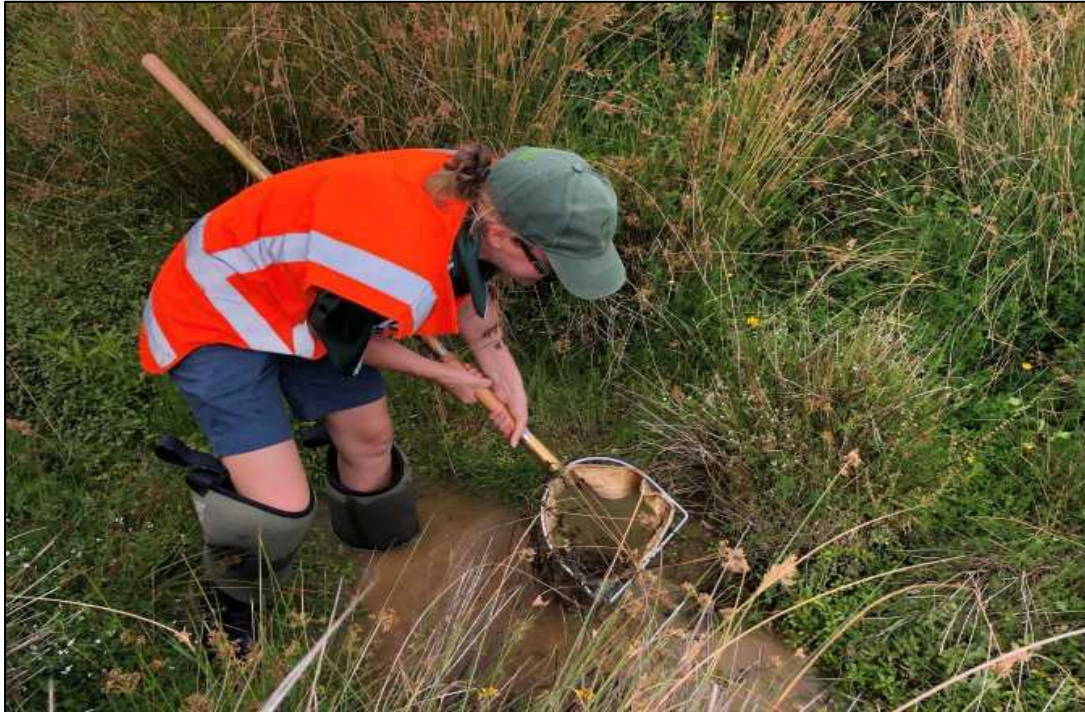
*Plate 6 Photo of macroinvertebrate sampling being undertaken within Tributary 1. Grazing of rushes by stock is clear from the photo.*

Shading varied from low to high and was provided mainly by the vegetation within the channel. Stock access was unimpeded along the length of the stream. Streambed morphology showed little variation with only slow runs and small pools present along the reach. Channel morphology exhibited some variation with narrow meanders present in some places. There was also evidence of some in-flow from Pond E as marked on the concept designs by WSP-Opus (3/9/18, project number 3-39019.00).

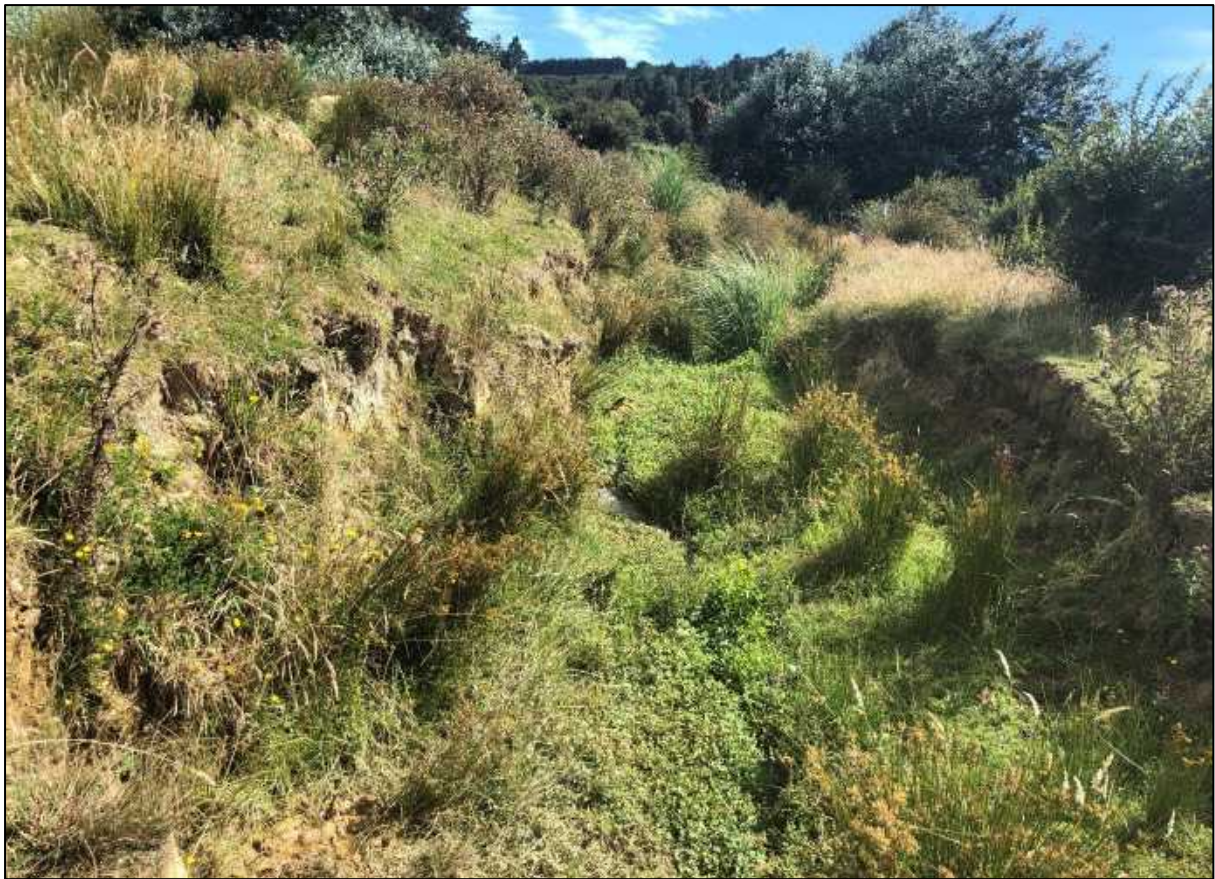
*Plate 7 Photo of outfall drain showing the clearly defined and excavated channel.*

This drain was soft-bottomed (clay) with virtually no variation in channel morphology but some variation in streambed morphology, with runs and riffles present due to collapsed clay clumps. Watercress, *Juncus* sp. and curly pondweed (*Potamogeton crispus*) were present within the channel. Water depth was fairly uniform at around 0.2m and although the water still retained some of the lime-green cloudy appearance as seen in the ponds, the clarity was 42cm using a clarity tube. Shading was relatively poor, as it was mostly provided by the steep banks. Direct stock access was possible along the length of the channel with pugging of the banks evident, and it flowed for approximately 80m before exiting the site into the neighbouring property. The confluence with Stream 1 was not visible from the site.

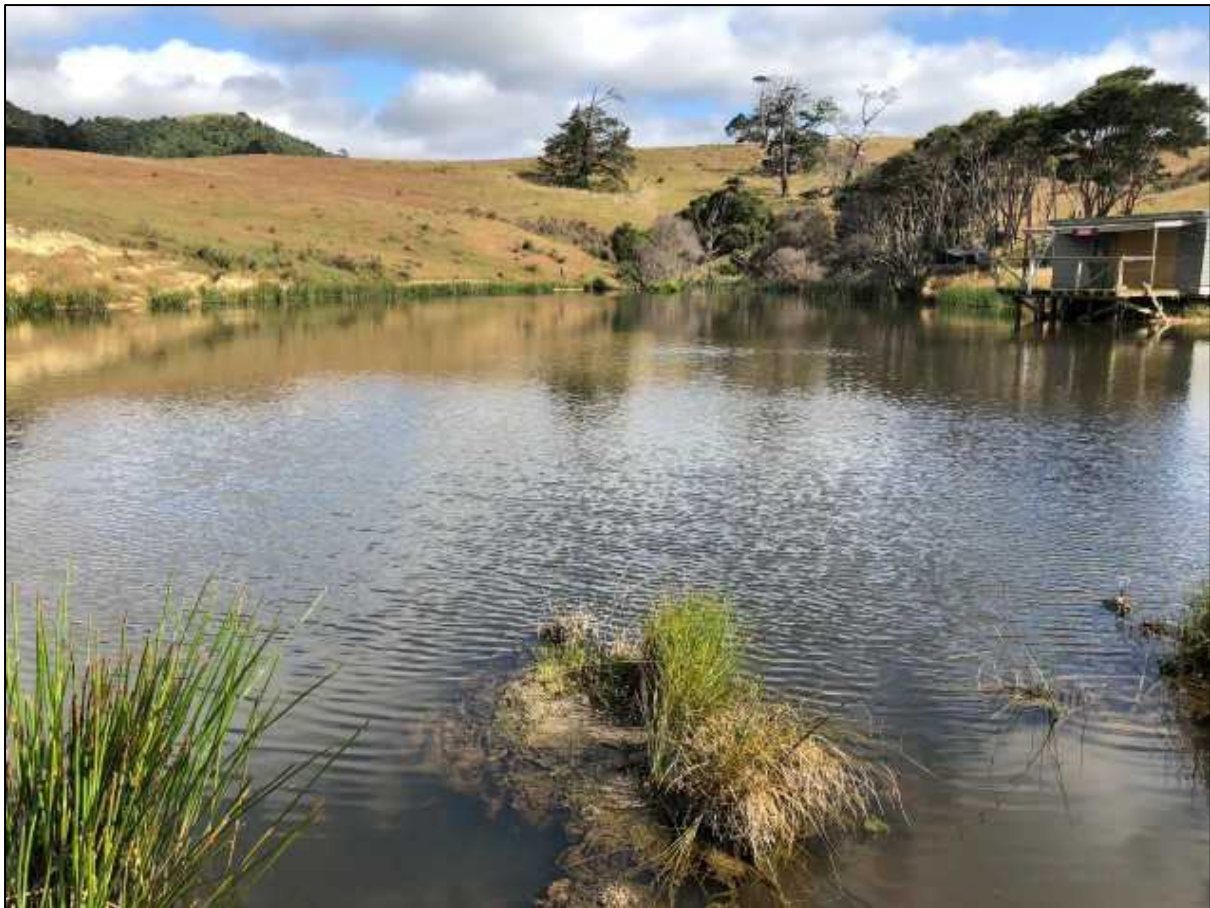
*Plate 9 Pond 2 from the southern bank.*

Pond 2 was significantly larger than Pond 1 having a length of roughly 130m and covering an area of approximately 6,500m<sup>2</sup> (Plate 9). A large maimai on stilts was present on the eastern bank for duck shooting. Pond 2 was also noted to be artificial, likely formed by damming of the headwaters of a watercourse historically. However, given the length of time this pond has been established it is impossible to determine the historical characteristics of the watercourse. Unlike Pond 1, there is connectivity to the wider catchment, a culvert was noted at the southern end discharging into the native bush below. It is expected that this discharge forms part of the source of Tributary 1. At the time of the assessment, there was no flow visible leaving the pond.
