Attachment B: s92 Request Response

Re: Further Information Request, s92 Response - McPherson Quarry, Mangawhiri

MCPHERSON QUARRY | WAIKATO | JANUARY 2020 | R2

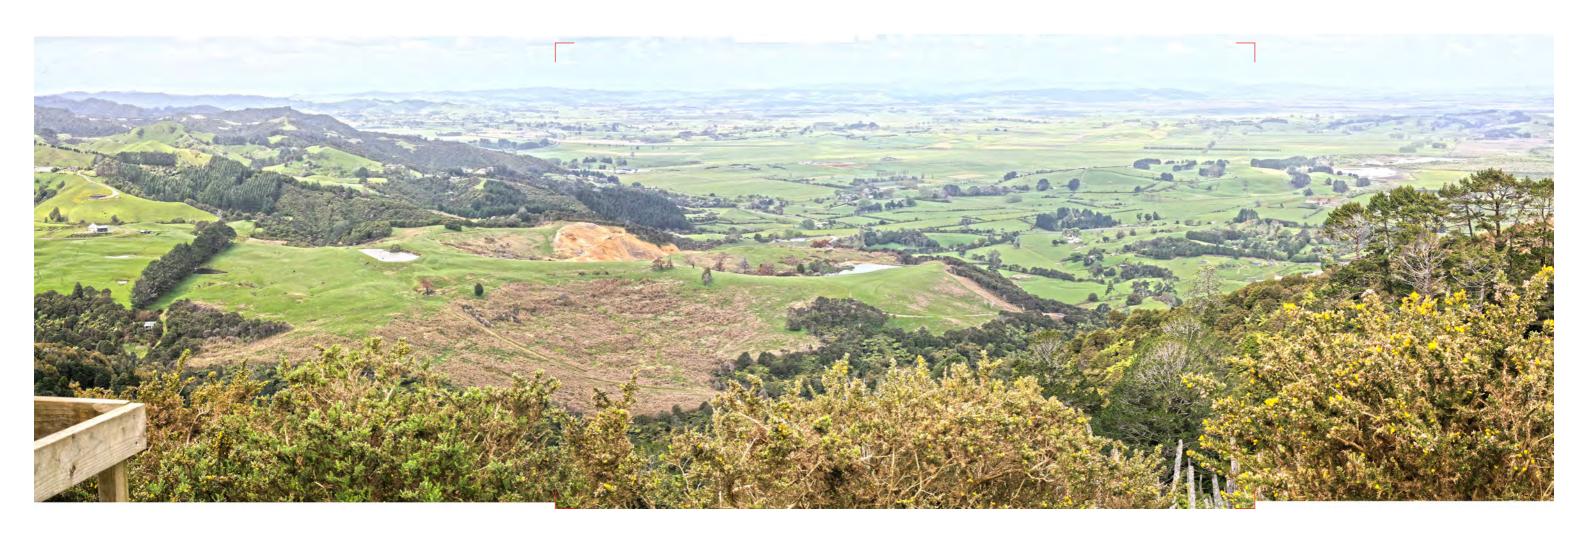
A 3D digital model of the proposed development was produced and accurately superimposed into each image using a combination of Adobe Photoshop CC 2019 ArcGIS Pro and Vectorworks 2019, in accordance with NZILA best practice guidelines Panoramic view was merged from 50mm frame images, Photo montaging by MGLA.

The overburden disposal area (ODA) is not shown in the visual simulation supplied to Council. The layer showing this aspect was accidentally left switched off on the proposed montages. This has been corrected in the attached montages.

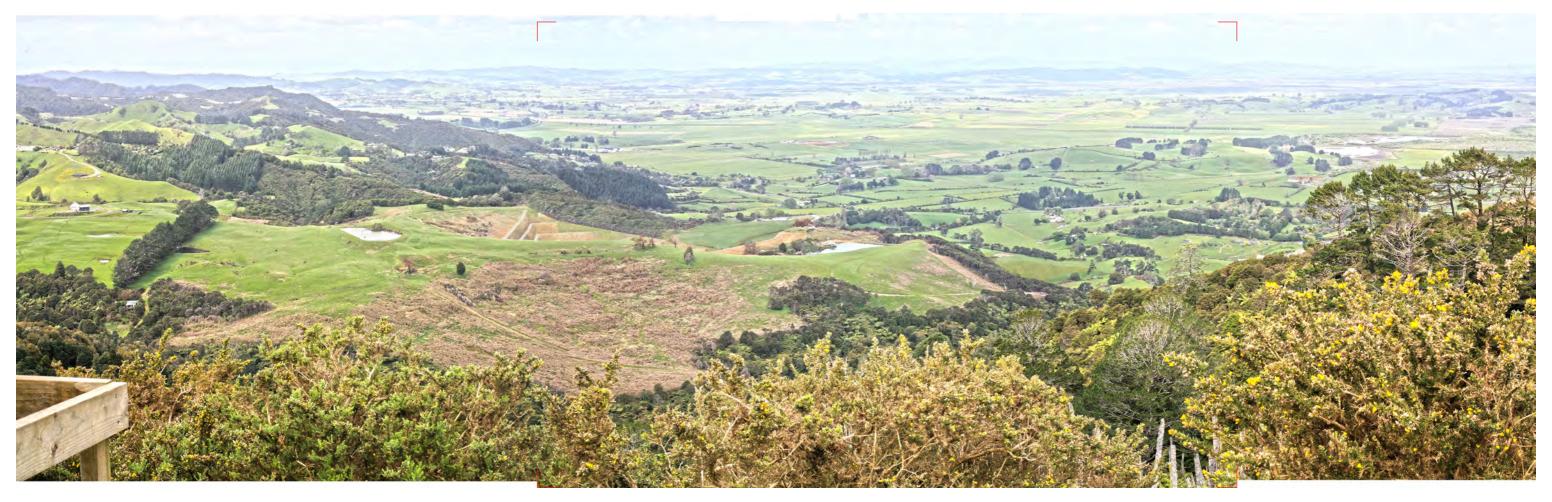
*MITIGATION PLANTING NOT SHOWN

A 3D digital model of the proposed development was produced and accurately uperimposed into each image using a combination of Adobe Photoshop CC 2019, urcGIS Pro and Vectorworks 2019, in accordance with NZILA best practice guidelines.

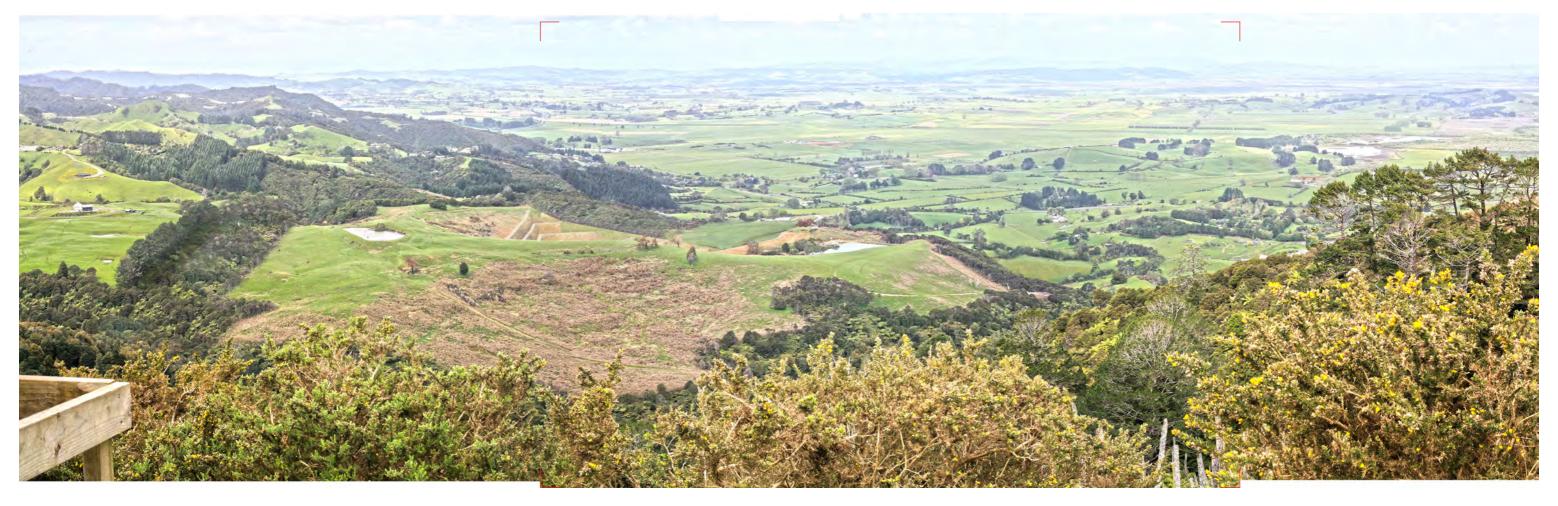
VIEW LOCATION SEVEN - PROPOSED STAGE 1 VIEW LOOKING EAST FROM MT WILLIAM (WITH MITIGATION PLANTING)

*WITH ECOLOGIACL AND MITIGATION PLANTING

A 3D digital model of the proposed development was produced and accurately superimposed into each image using a combination of Adobe Photoshop CC 2019, ArcSIS Pro and Vectorworks 2019, in accordance with NZILA best practice guidelines.

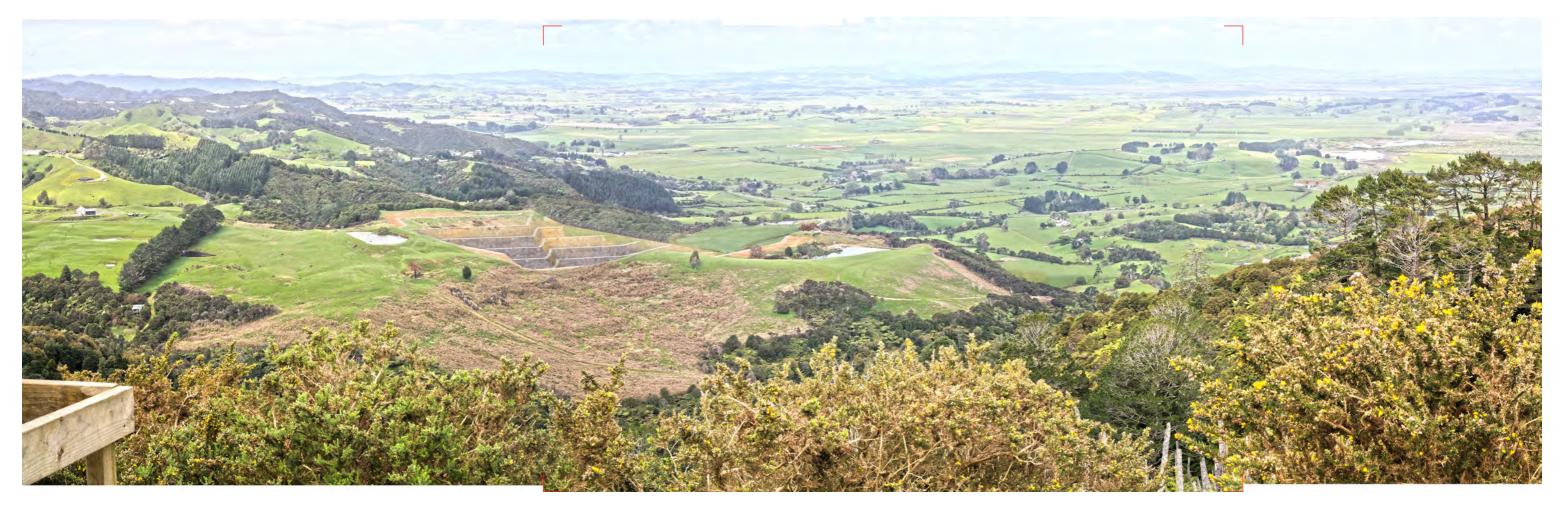
VIEW LOCATION SEVEN - PROPOSED STAGE 2 VIEW LOOKING EAST FROM MT WILLIAM (WITHOUT MITIGATION PLANTING)

*MITIGATION PLANTING NOT SHOWN

A 3D digital model of the proposed development was produced and accurately superimposed into each image using a combination of Adobe Photoshop CC 2019, ArcGIS Pro and Vectorworks 2019, in accordance with NZILA best practice guidelines. Panoramic view was merged from 50mm frame images, Photo monitaging by MGLA.

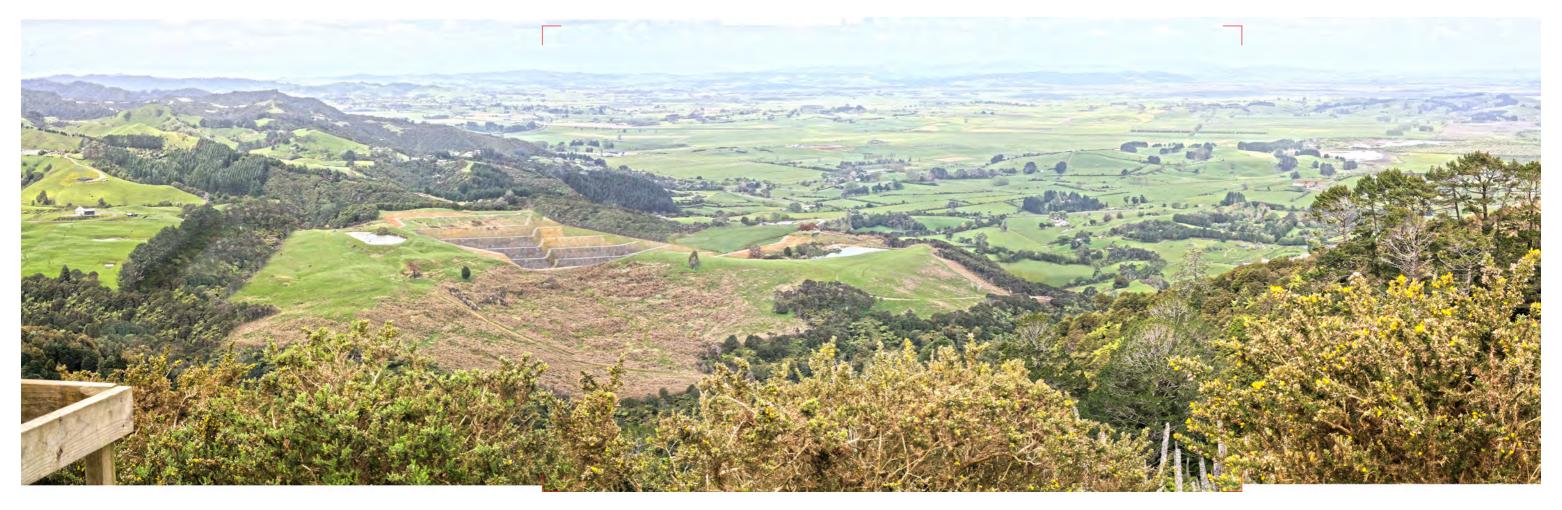
*WITH ECOLOGIACL AND MITIGATION PLANTING

NZTM Easting: 1779634.4985 NZTM Northing: 5880092.3644 Focal length: 50mm Photographer: D.Mansergh

Camera: D.Marisergh Canon EOS D5 Full Frame Digi with EF 50mm F/1.4 USM (Prim Date: 23rd October 2019

A 3D digital model of the proposed development was produced and accurately superimposed into each image using a combination of Adobe Photoshop CC 2019 ArcGIS Pro and Vectorworks 2019, in accordance with NZILA best practice guidelines Panoramic view was merged from 50mm frame images, Photo montaging by MGLA.

Image should be viewed at a distance of 260 mm to approximate actual scale.

It should be noted that the visual simulations represent the end of each stage of extraction (i.e. completed pit and overburden disposal). Because overburden stripping and disposal will occur at the beginning of each stage, the ODA will be at a point where it already has been filled and regressed. During overburden stripping and placement, a small portion of the overburden stockpile area will be exposed to view while

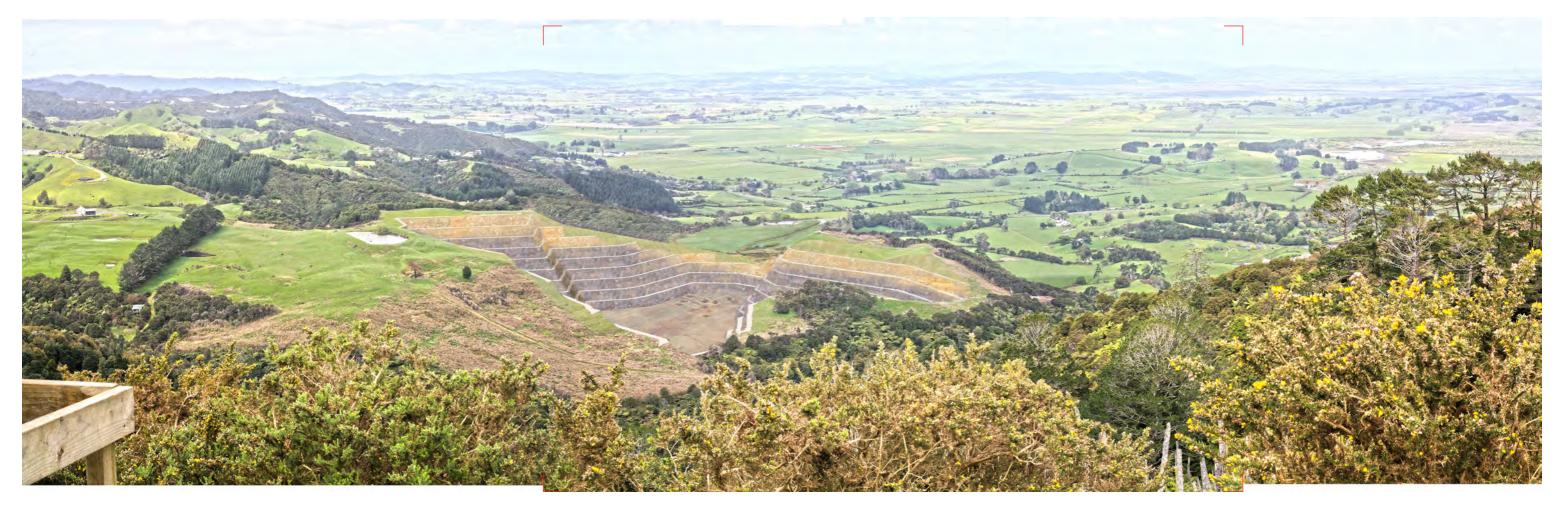
VIEW LOCATION SEVEN - PROPOSED STAGE 3 VIEW LOOKING EAST FROM MT WILLIAM (WITHOUT MITIGATION PLANTING)

*MITIGATION PLANTING NOT SHOWN

Camera: Canon EOS D5 Full Frame Digi with EF 50mm F/1.4 USM (Prim Date: 23rd October 2019 A 3D digital model of the proposed development was produced and accurately superimposed into each image using a combination of Adobe Photoshop CC 2019, ArCGIS Pro and Vectorworks 2019, in accordance with NZILA best practice guidelines. Panoramic view was merged from 50mm frame images, Photo montaging by MGLA.

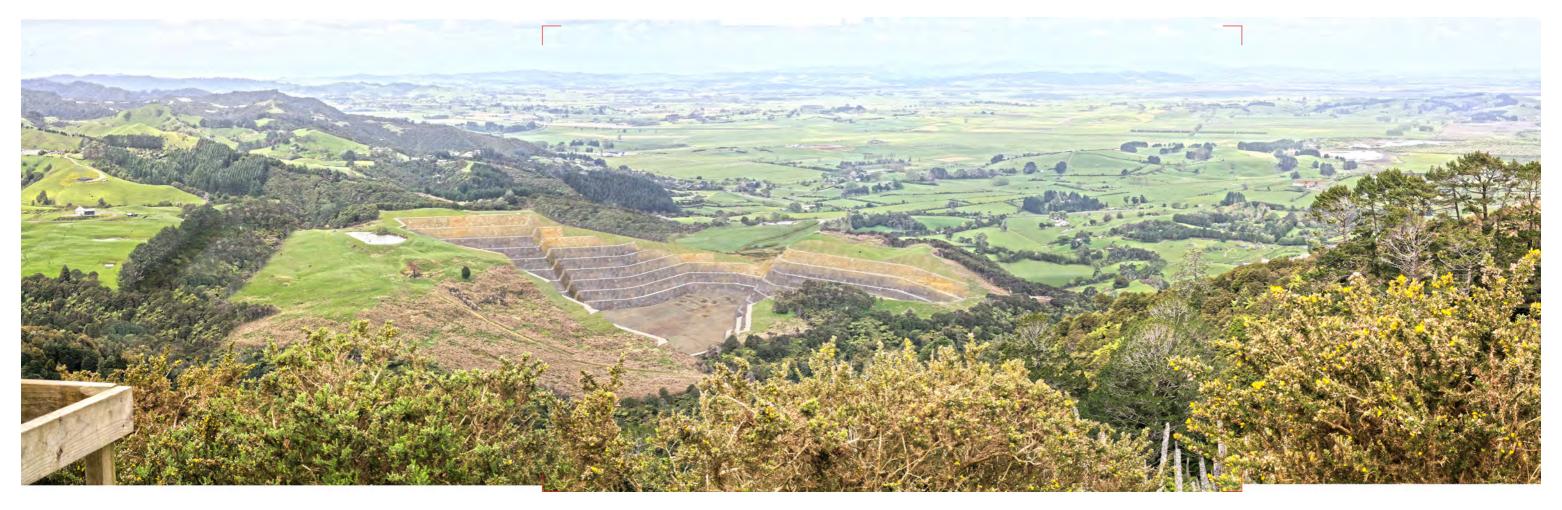
VIEW LOCATION SEVEN - PROPOSED STAGE 3 VIEW LOOKING EAST FROM MT WILLIAM (WITH MITIGATION PLANTING)

*WITH ECOLOGIACL AND MITIGATION PLANTING
