Landscape & Visual Assessment (Opus)

McPhersons Quarry Ltd

McPhersons Quarry Expansion Proposal Landscape and Visual Assessment

Date: 31 August 2018
Reference: 3-39019.00
Status: Issue 1

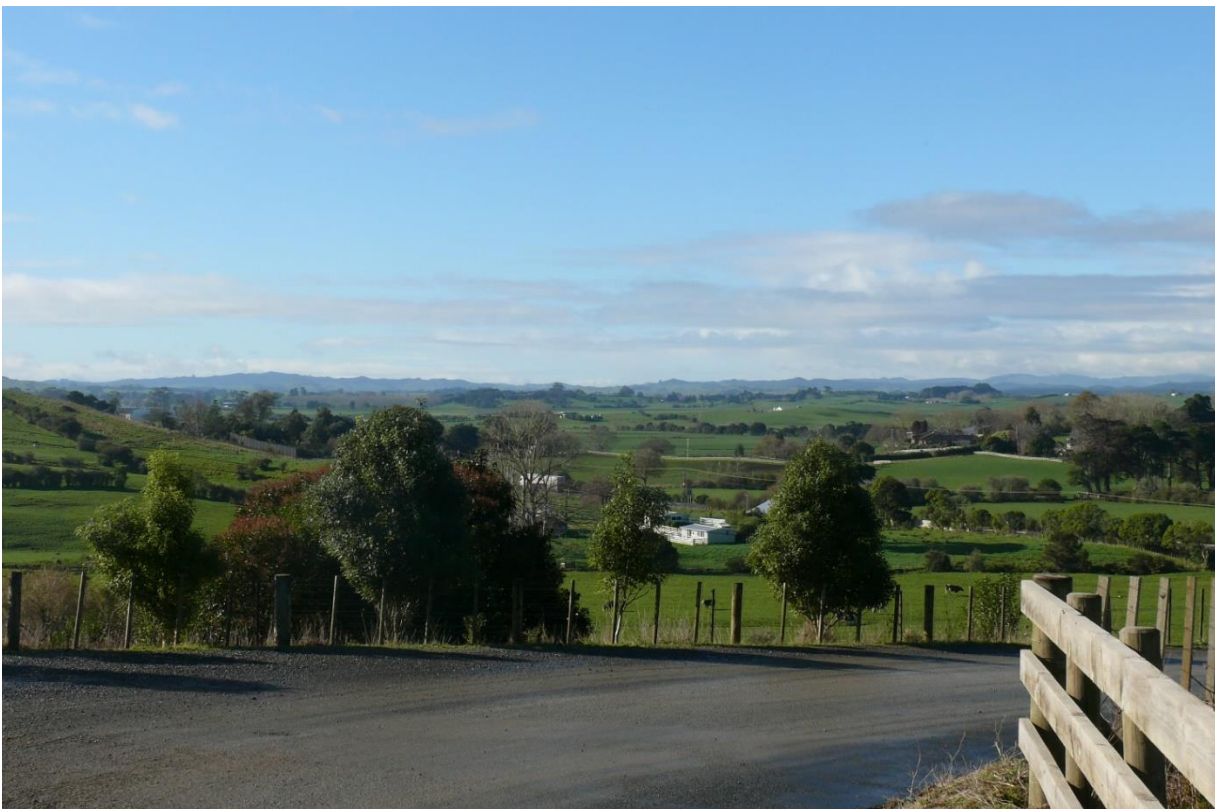
Photo 1 – view to the south east from quarry entrance, looking over Hauraki Plains. Features are largely pastoral with assorted vegetation patterns, predominantly in shelter belts or stands of trees.

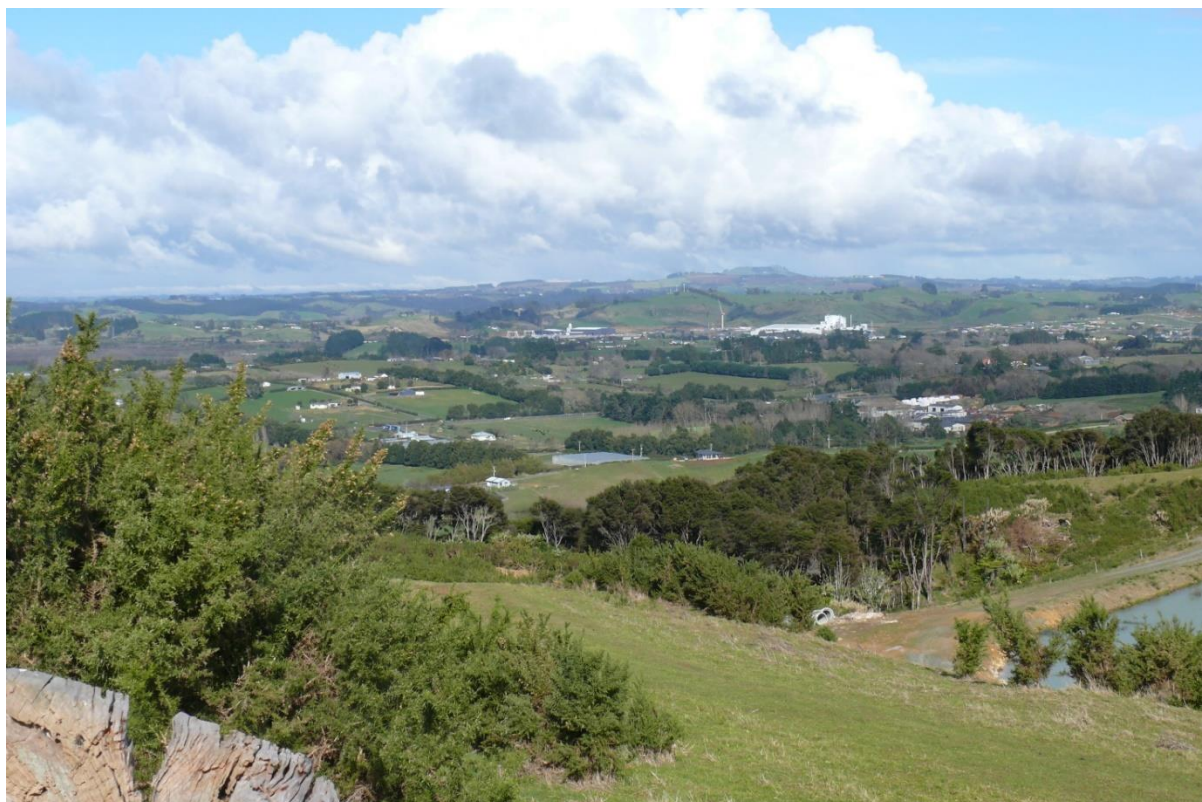
Photo 2 – view to south west toward Pokeno, Yashily Milk plant is the large white structure. Landscape includes mix of pasture and shelter belt/ hedge planting with scattered buildings.

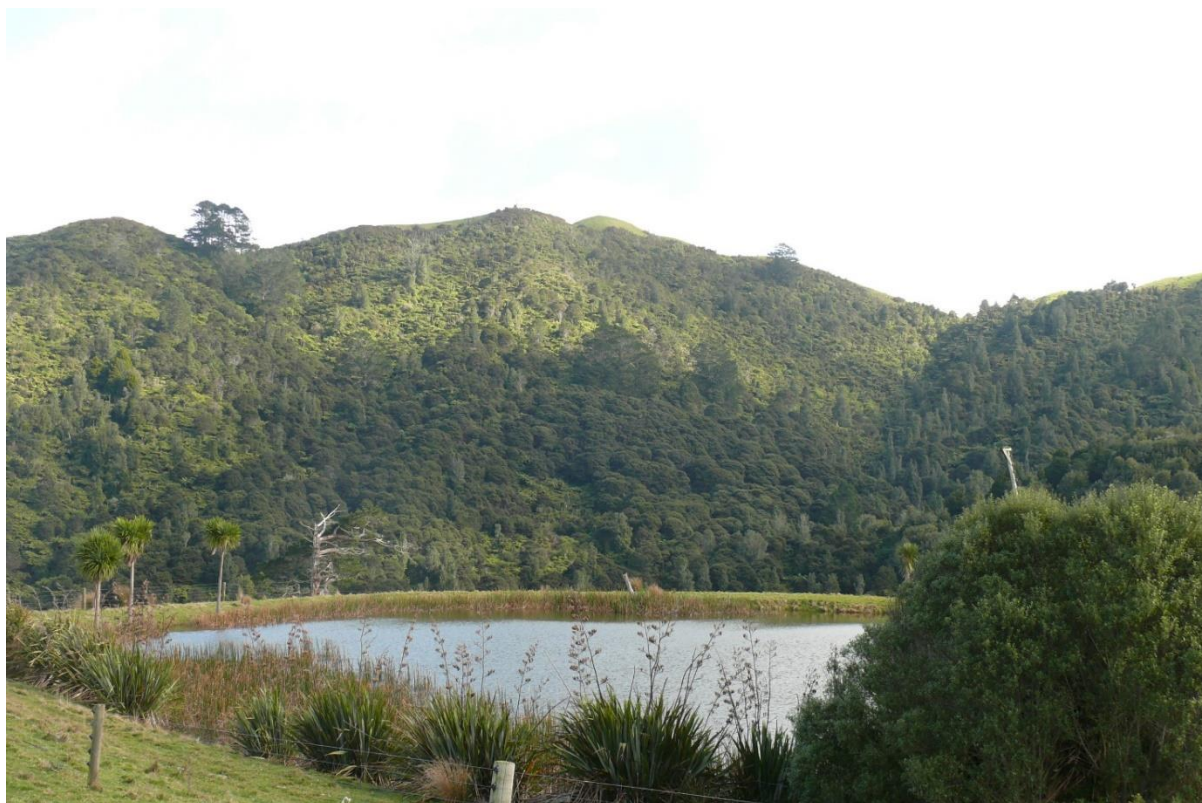
Photo 3 – view to west toward Mount William summit. Track is located in bush on lower extent before continuing in pasture to the summit. Track is approximately 1200m west of the existing quarry. The bush covered slopes are part of the Significant Natural Area. Pond A in the foreground.

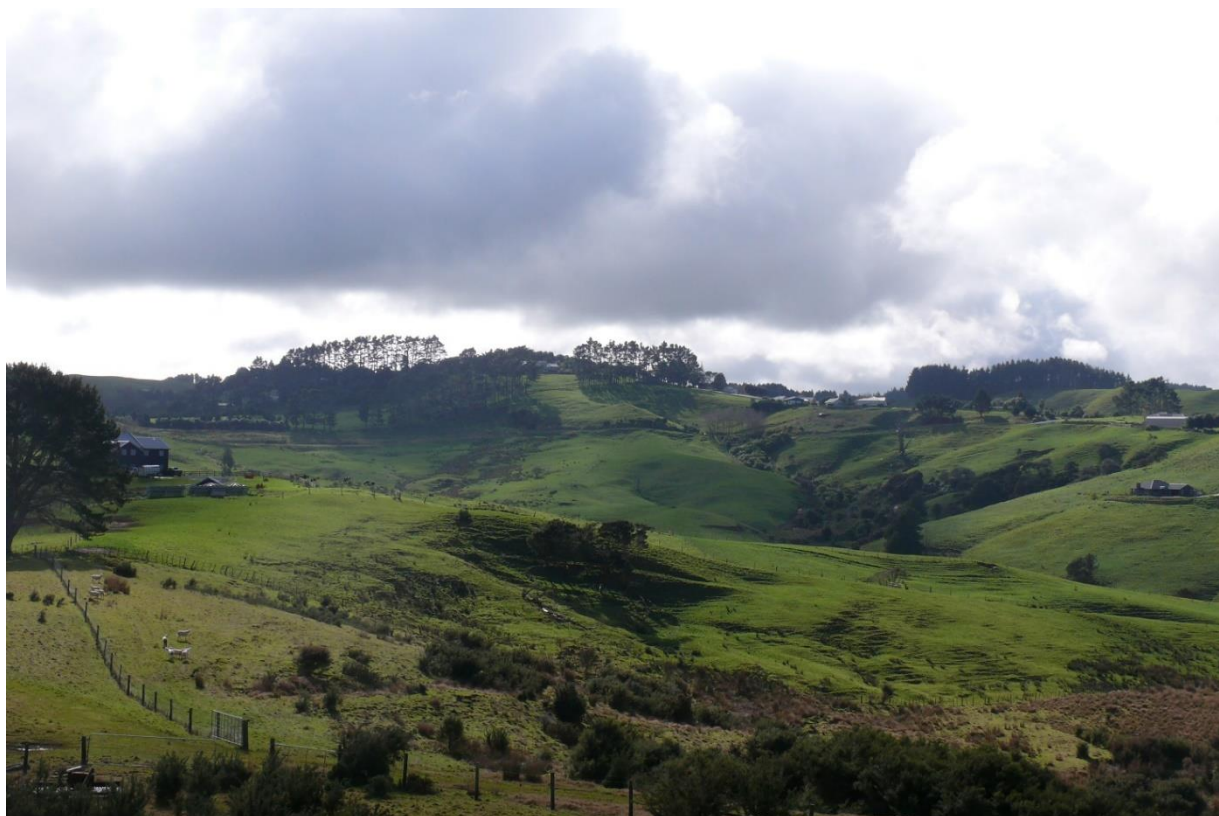
Photo 4 – view to north toward Pinnacle Hill Road, features include more undulating landform, exotic tree cover in shelter belts and stands, large areas of pasture, scattered buildings.

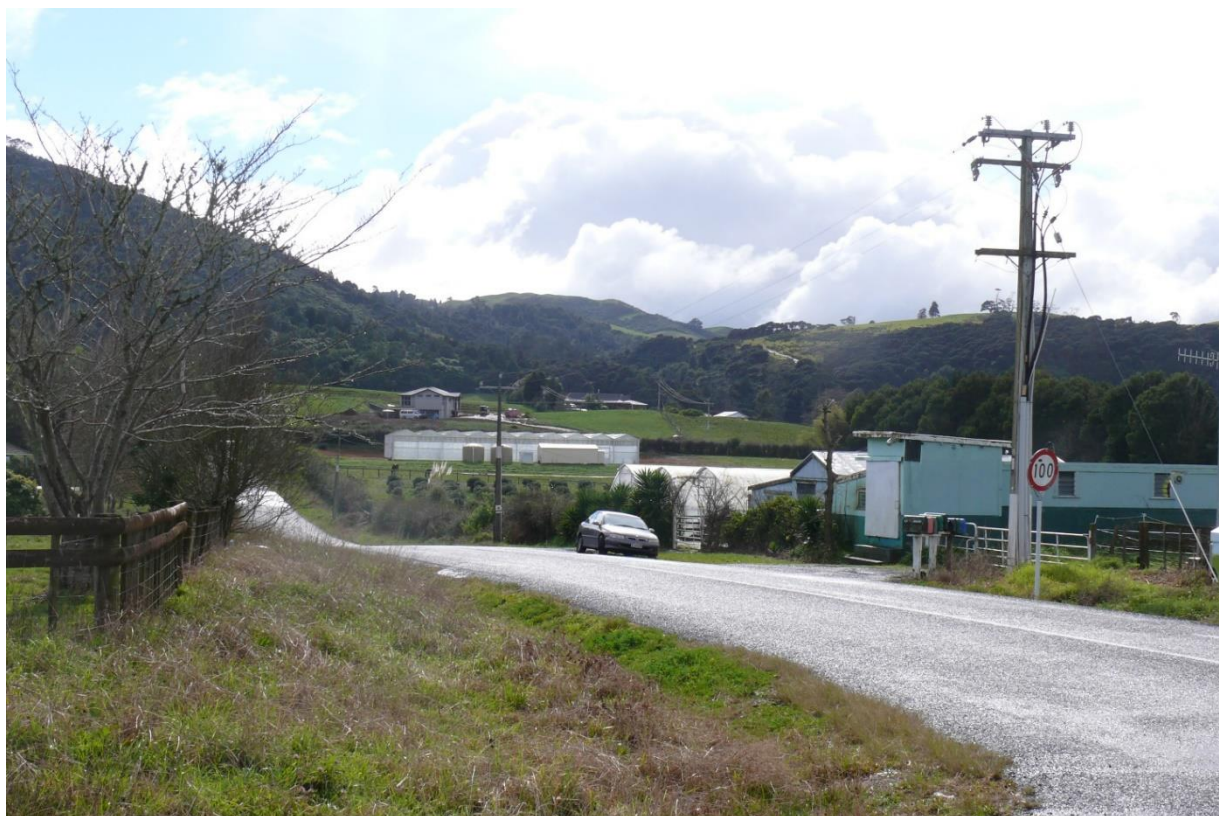
Photo 5 – view from intersection SH2 and Irish Road, looking north. Landscape includes more built features of a larger scale, hedges, pasture and shelterbelts. Roads have no kerbs or footpaths. Undulating hill country background.

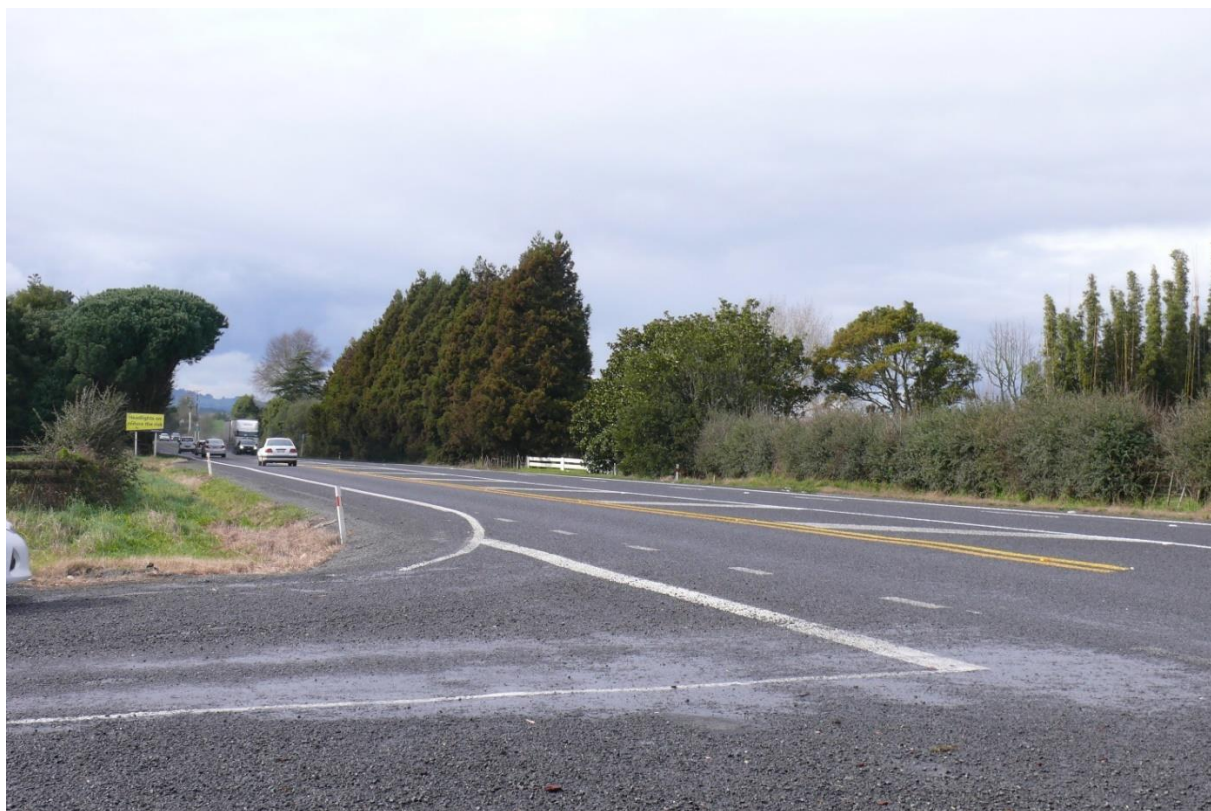
Photo 6 – view from intersection SH2 and Irish Road, looking along SH2 to east. Road is enclosed by shelter planting. Traffic volumes vary by time, day and season. High speed environment (90km/h).

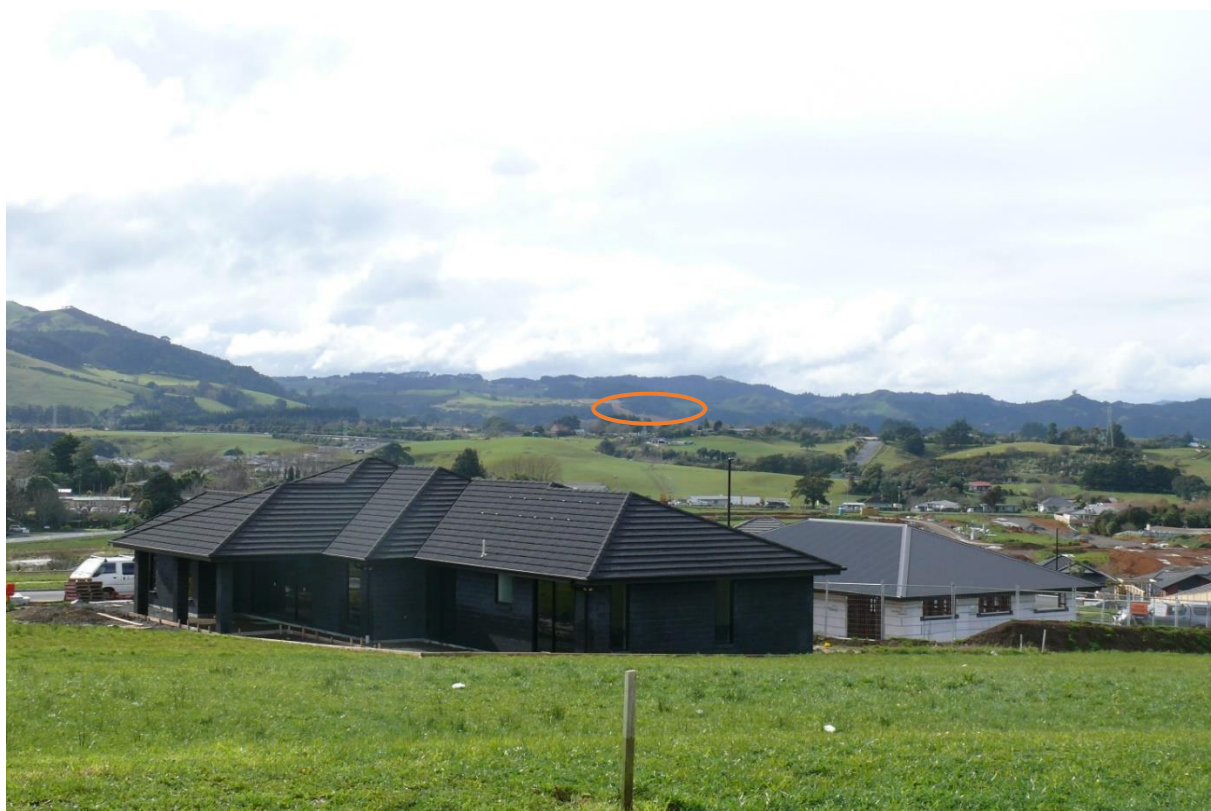
Photo 7 – view of wider landscape from Pokeno, pasture planting. Approximate site highlighted.

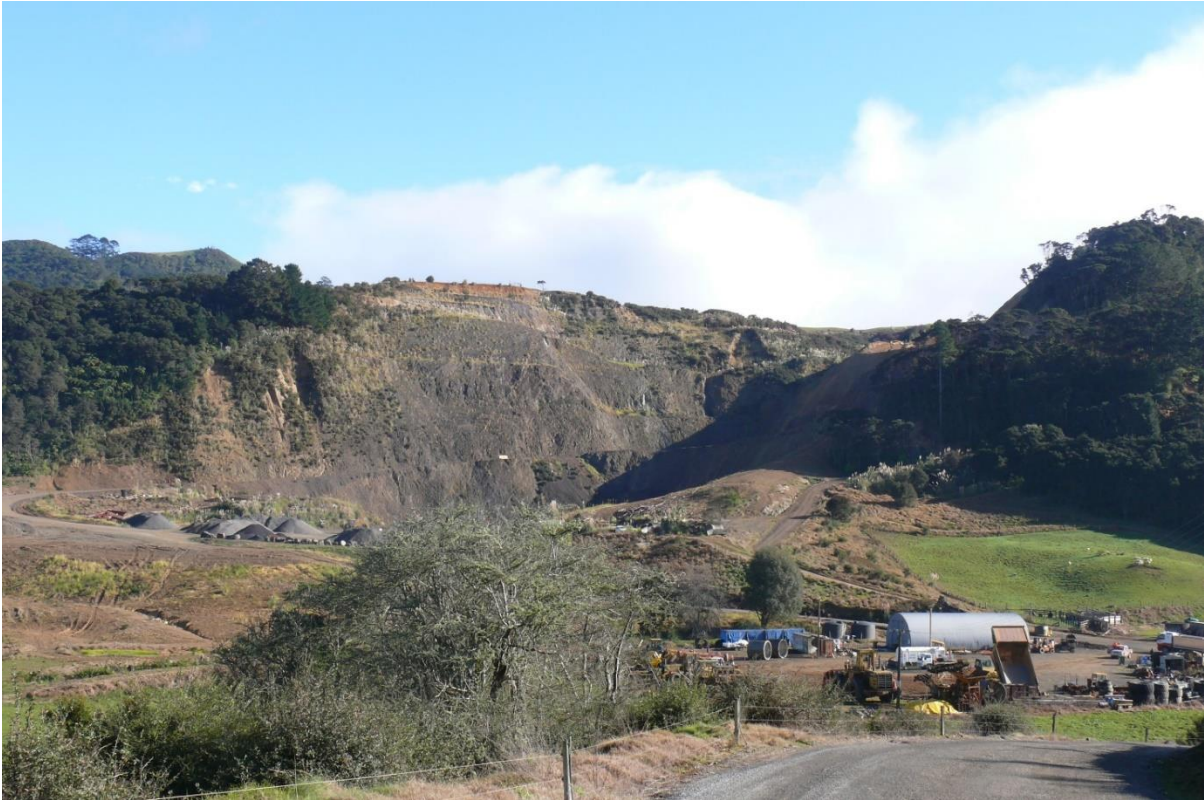
Photo 8 – view of existing quarry, looking north from site entrance

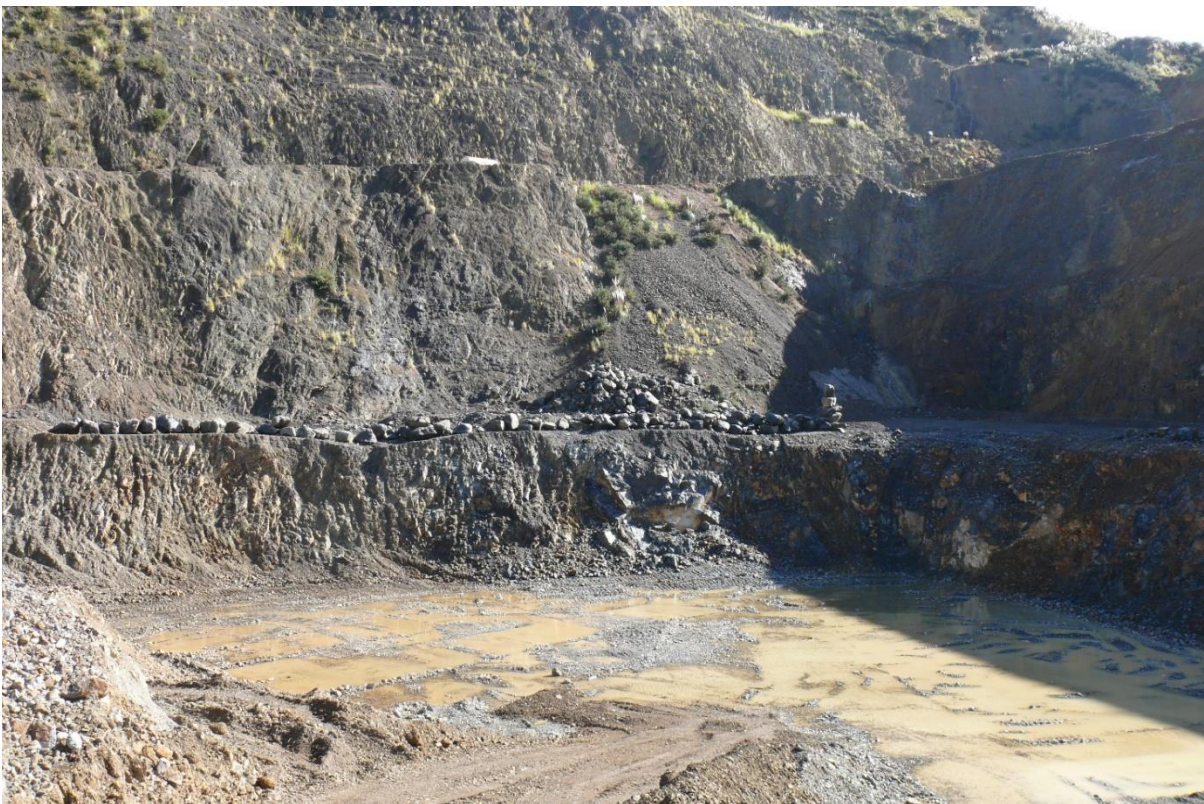
Photo 9 – view of existing quarry face

The quarrying activity is not new to the landscape, as the quarry has been in operation over 60 years, and as such is considered part of the existing landscape character. The noticeable differences from the surrounding landscape are the variation in colour, with the quarry face ranging from the yellow/ brown soils to the dark grey/ blue rock, with contrasts with the varying shades of green found in the pasture and bush cover. With the quarry faces being predominantly south facing, there are effects created by the sun at various times of the day, where the all or part of the face is in deep shade, reducing the contrast with the surroundings.
